POLO & ASSOCIATES HOME INSPECTIONS, LLC

*Survey Abstract (*Summary of Concerns*)

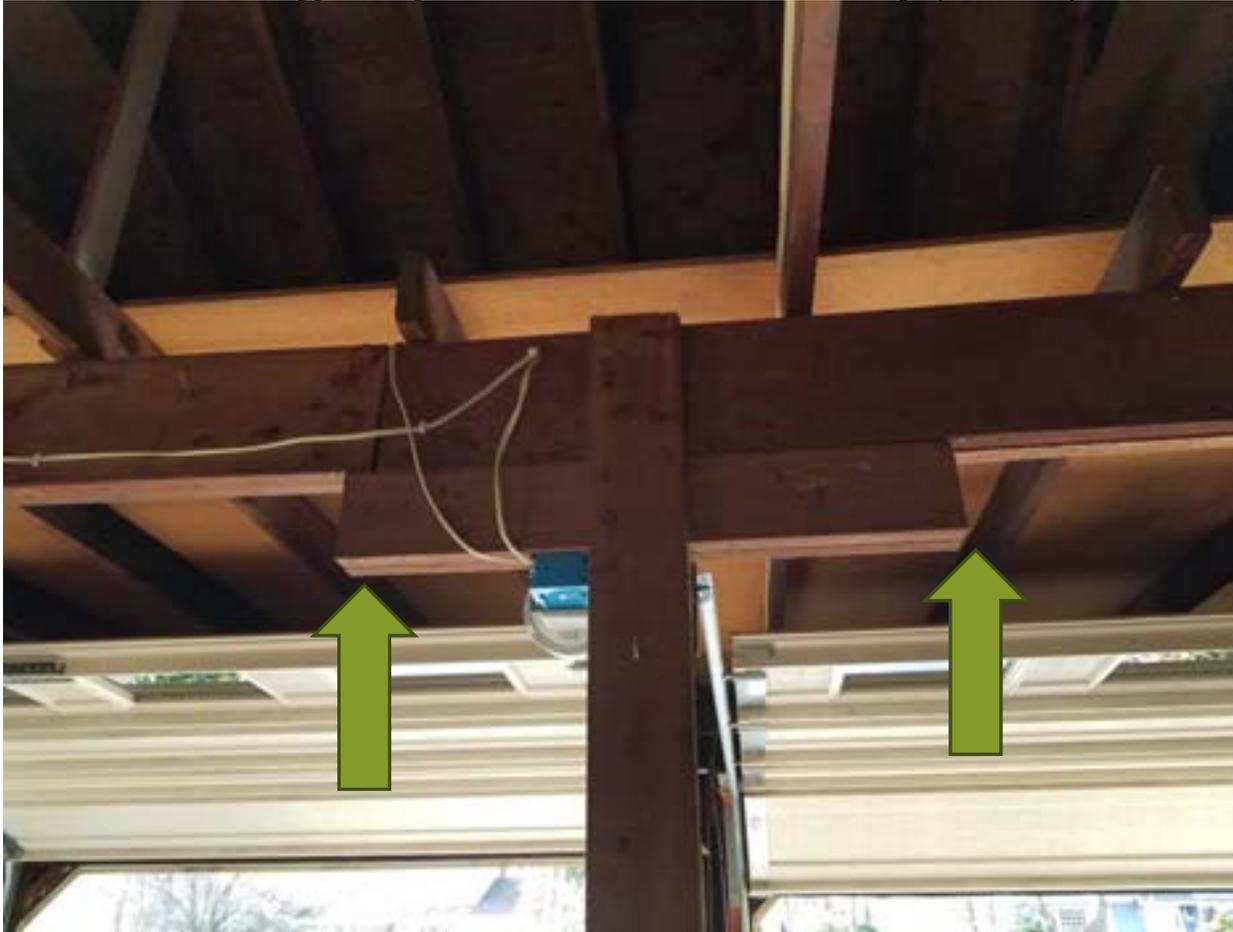
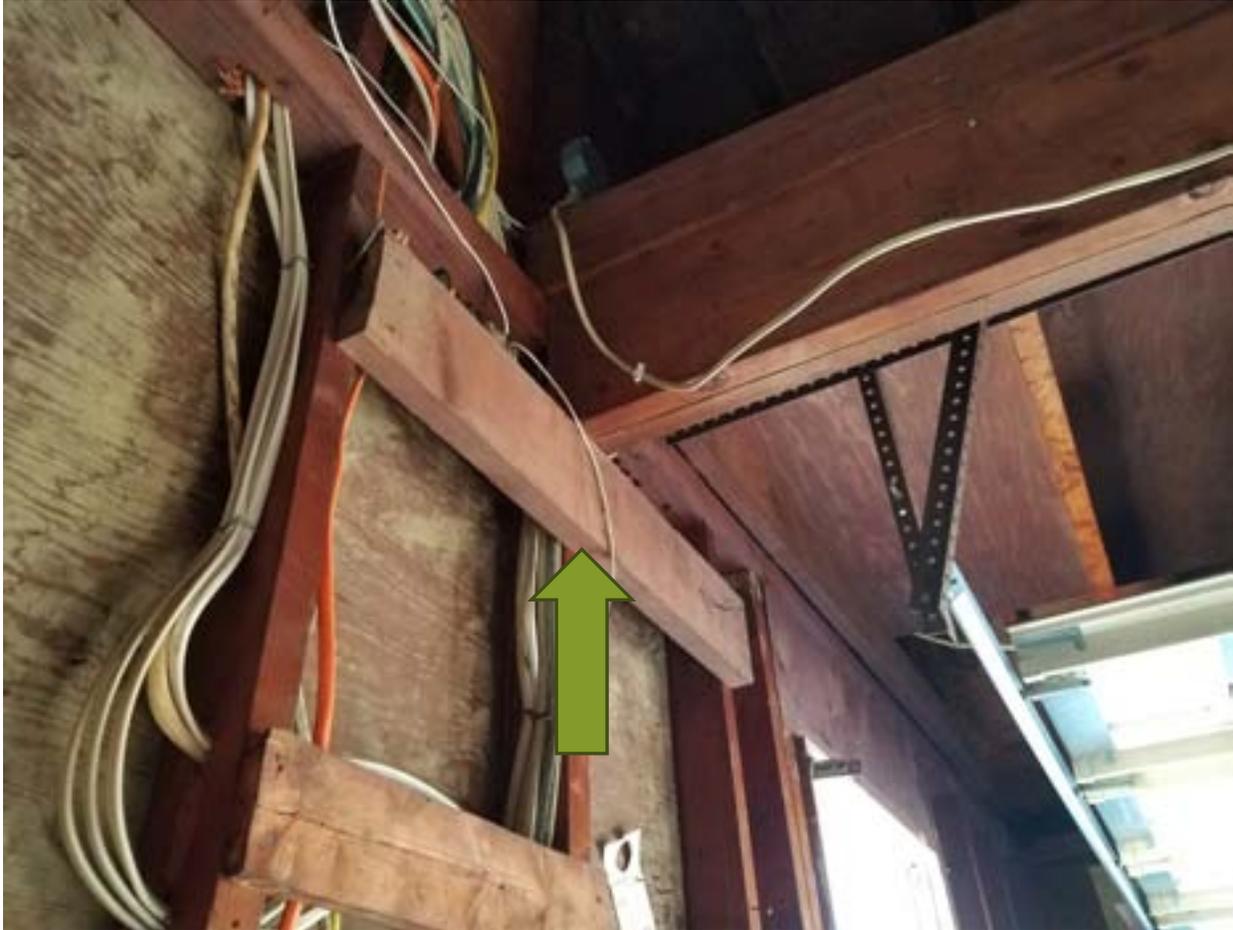
[1C.43](#) Beam (main in garage) bearing surface for both ends and at center (splices) have inadequate support. Repair is recommended for structural integrity and safety

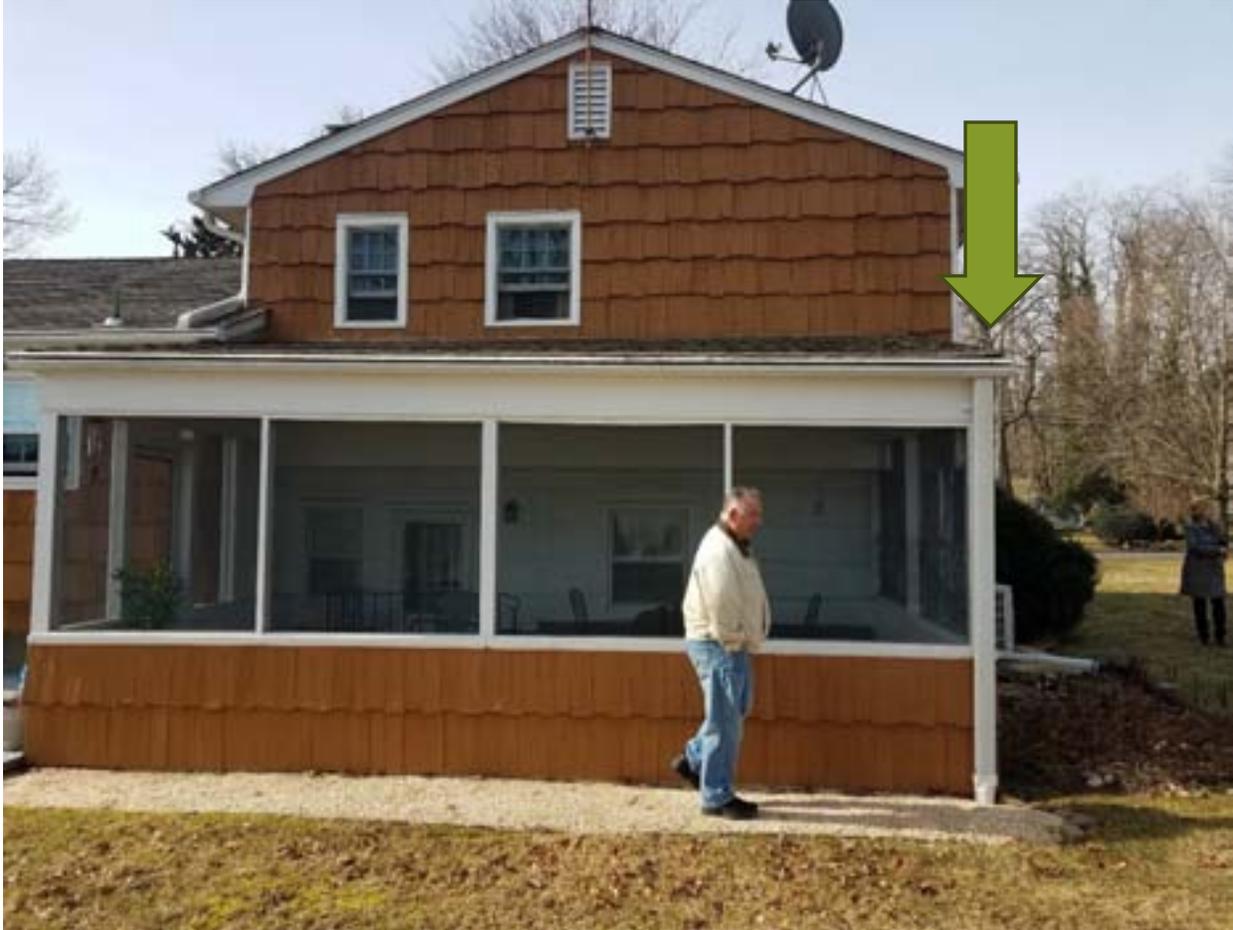
[1C.50](#) Instability/settling indicators & phenomena: typical, (within 1\8") vertical hairline/step cracks: Mortar and monitor for continued movement and if cracking continues contact a structural engineer; diagonal cracks in interior walls denotes structural settling; repair wall properly, adjust door if needed and monitor for future movement/cracking; sag/creep likely; settling/shrinkage/seating of wood frame likely

[1C.34](#) **Structural settling/out of level construction. Repair is recommended for structural integrity and safety where out of level for corner of rear porch addition**

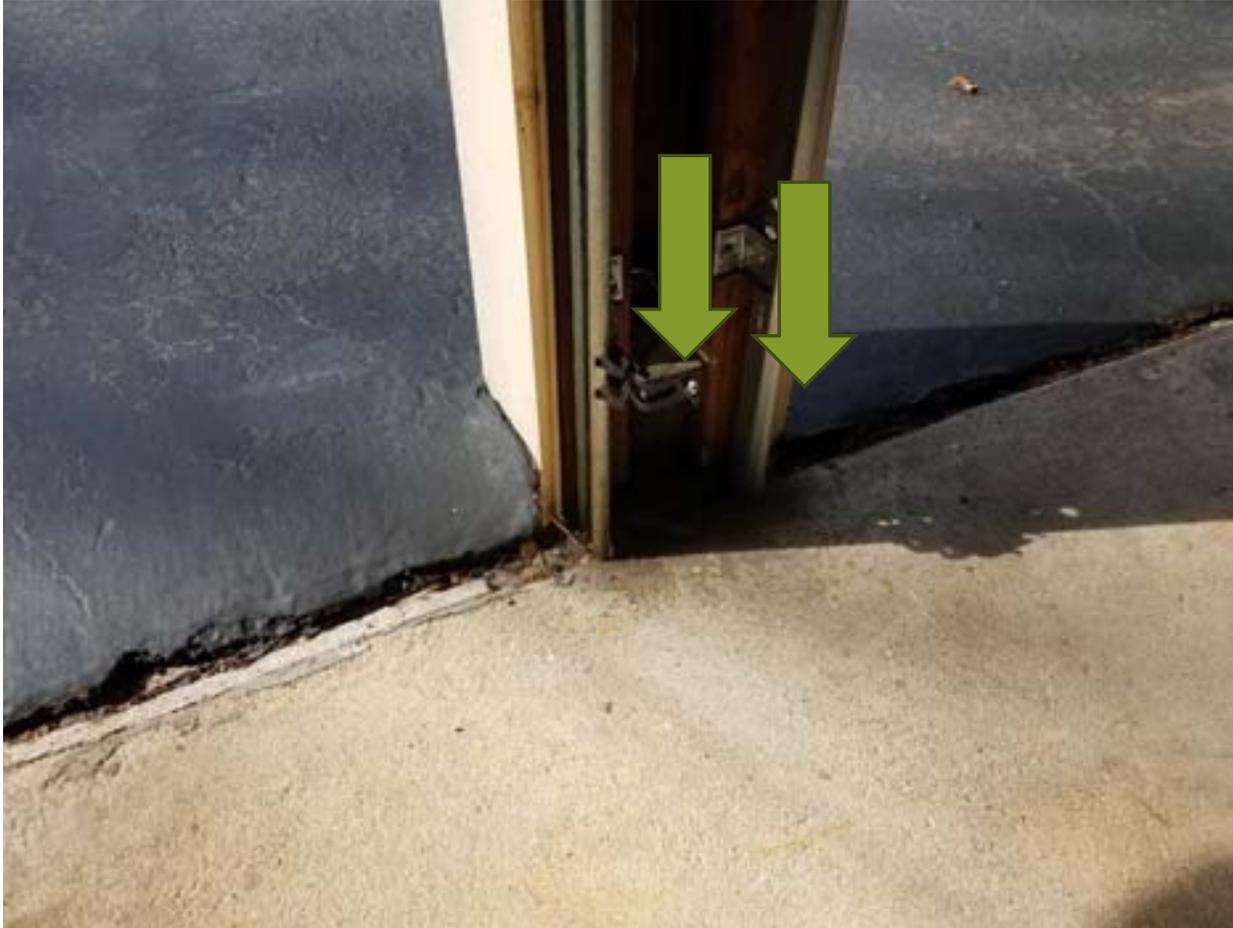
7C.09 Garage door safety sensor (optic eye laser) is installed more than 6" above floor:
Lower for increased safety on the right side

Garage door should have safety sensors for increased safety on the left side

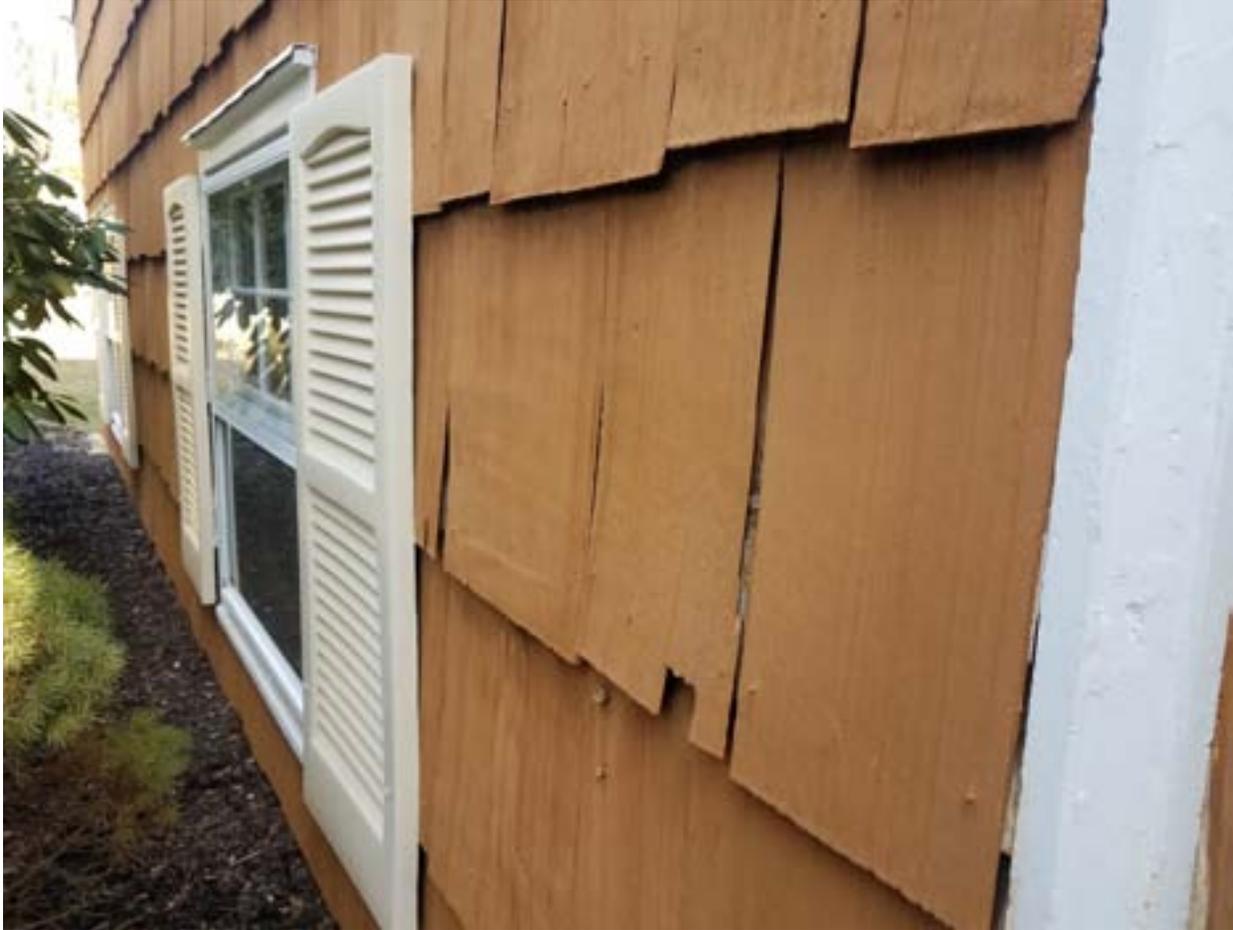
2P Paint, siding appears to be relatively recent and may be concealing rot, insect damage, mold, water damage, structural cracking, etc. Recommendation: Monitor for functionality

2C.23 Water penetration possible from many areas through inferior grade siding where poorly installed/damaged. Recommendation: Repair or replace as needed to prevent damage, etc

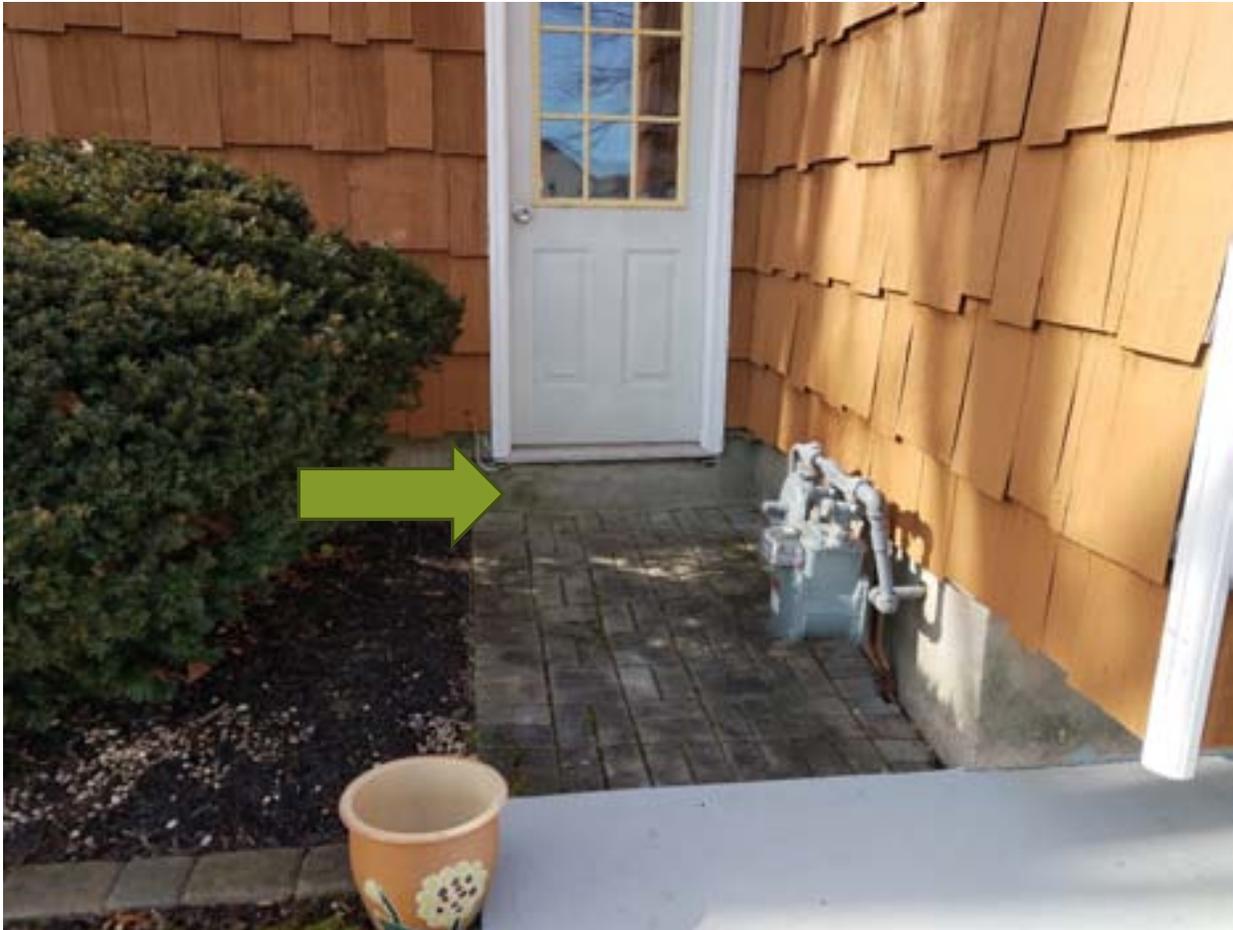
[2C.17](#) Step riser height should be less than 8" and apparently is not at the front and at the rear. Repairs are recommended to walks. This is a safety concern

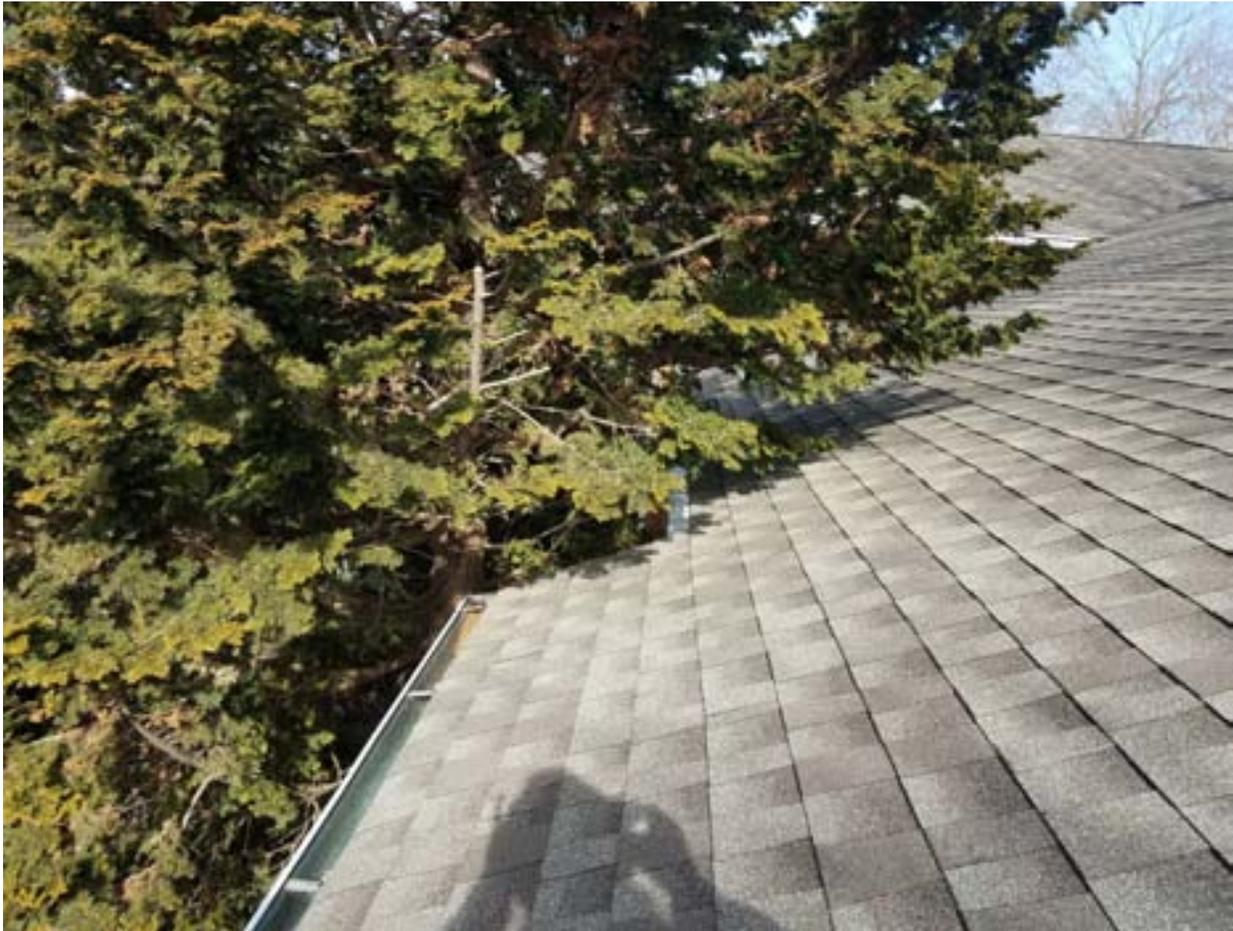
- [3C.06](#) Downspouts should extend further from house and terminate in open air to minimize water intrusion, settling, termite/pest infestation, etc
Commercial size gutters & downspouts are always recommended (especially with steep pitches, valleys, etc.) to prevent heavy rains from caroming over gutters
Leaves, seeds/water in gutters; service now and periodically to prevent water intrusion, ice dams, mold, rot, insect damage, etc. The addition of a permanent, professional gutter guard system is recommended to control excessive gutter debris and minimize maintenance (but only if soffits are properly ventilated in order to prevent ice damming)
- [1S.07](#) Trees/limbs are not assessed but must be maintained/removed so they cannot damage house or allow animals and insects on roof

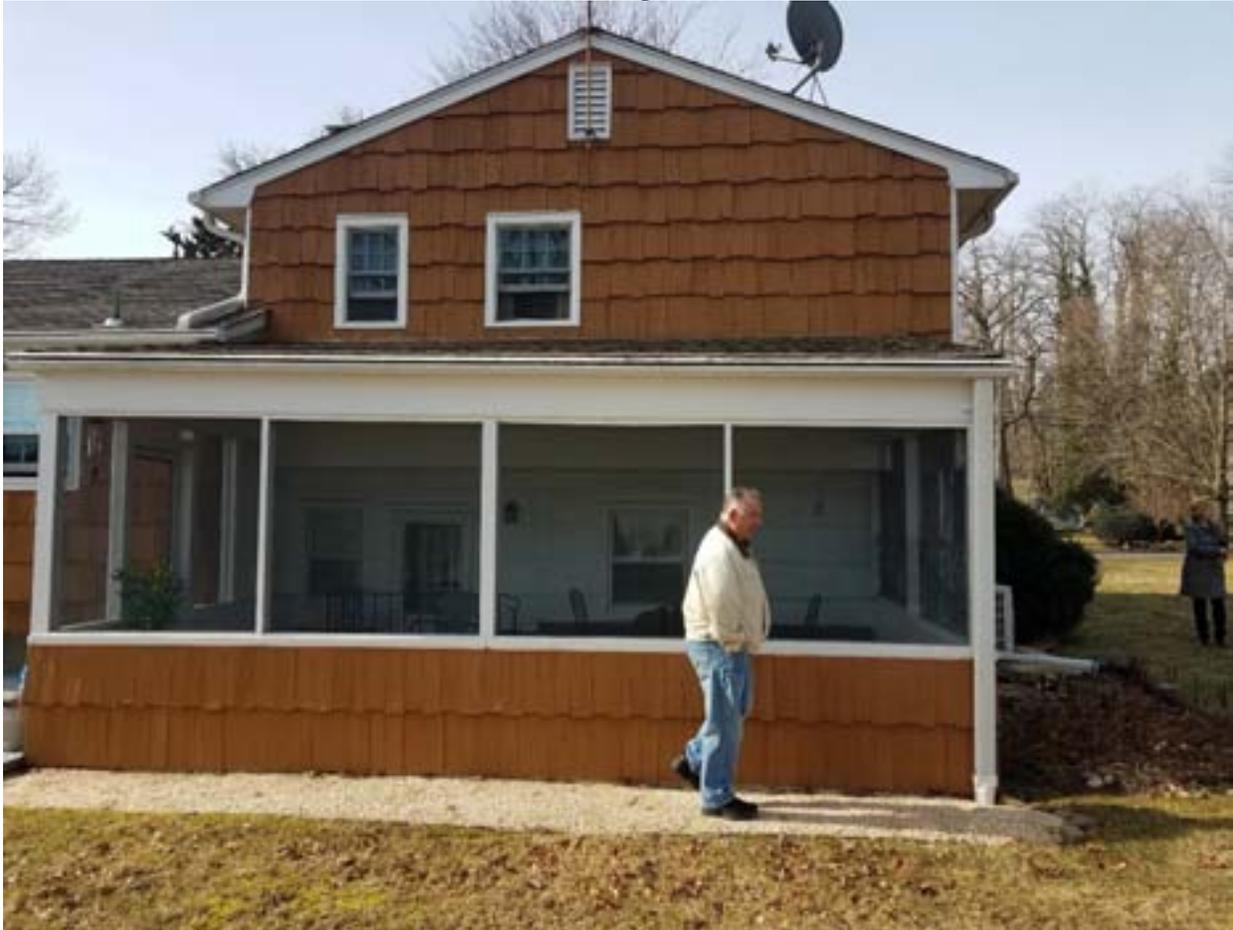
- [3C.12](#) Repairs silicone or caulk (temporary) on addition roof may indicate past or present leak:
Consult with sellers as to why this is needed or if it is just sloppy work
- [3C.03](#) Shingles, asphalt: eroded/pitted/granules missing is consistent with the aging process.
Recommendation: Monitor for future functionality
Multiple layers and darker colors of roofing will adversely affect roofs longevity of require additional ventilation, etc
- [3A.00](#) Slope (shallow pitch) 3/12 or less? Conventional shingles are not appropriate.
EPDM/modified roof is more appropriate and will provide a better seal for

wind, rain, ice damming, etc. Replacement is recommended prior to damage for rear addition. This is an expense concern

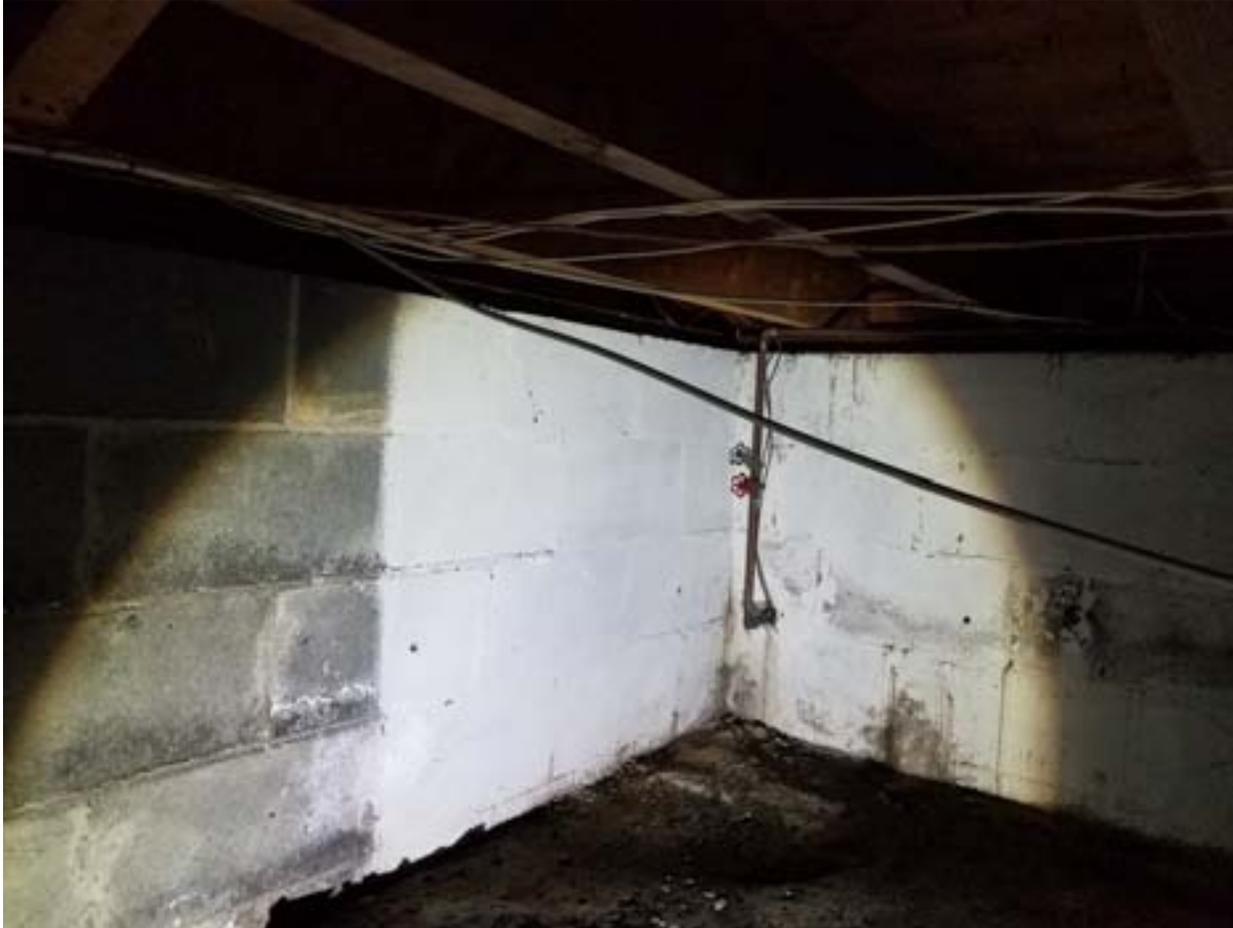
4A.00 Freeze-vulnerable piping. Repairs are recommended for pipes in crawl space; insulate perimeter and piping; seal off/eliminate ventilation and add thermostatically controlled heated cables to piping, etc. so pipes do not freeze again

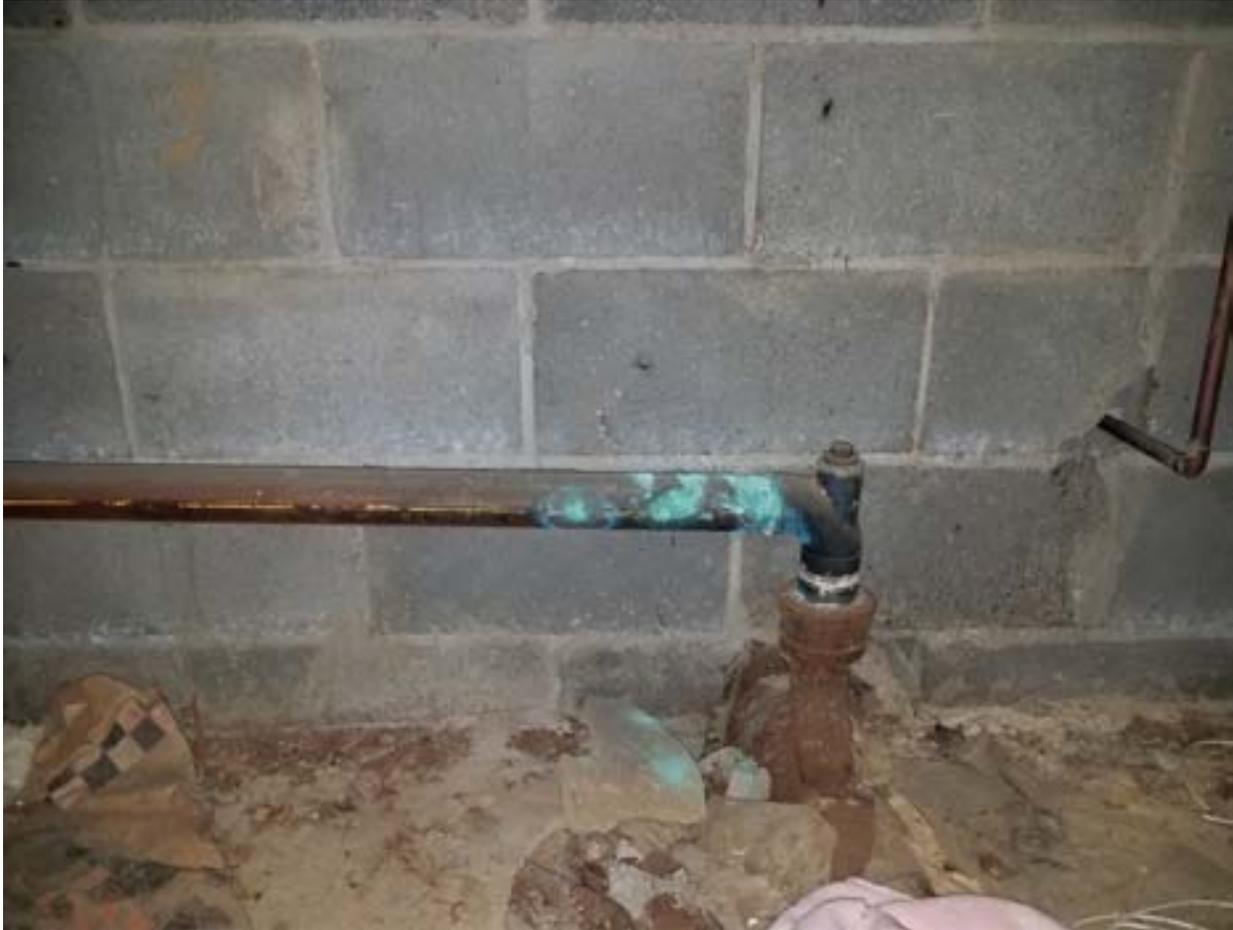
4C.01 Leak, water: drain from bathroom sink in the foundation crawl space. Recommendation: Repair or replace

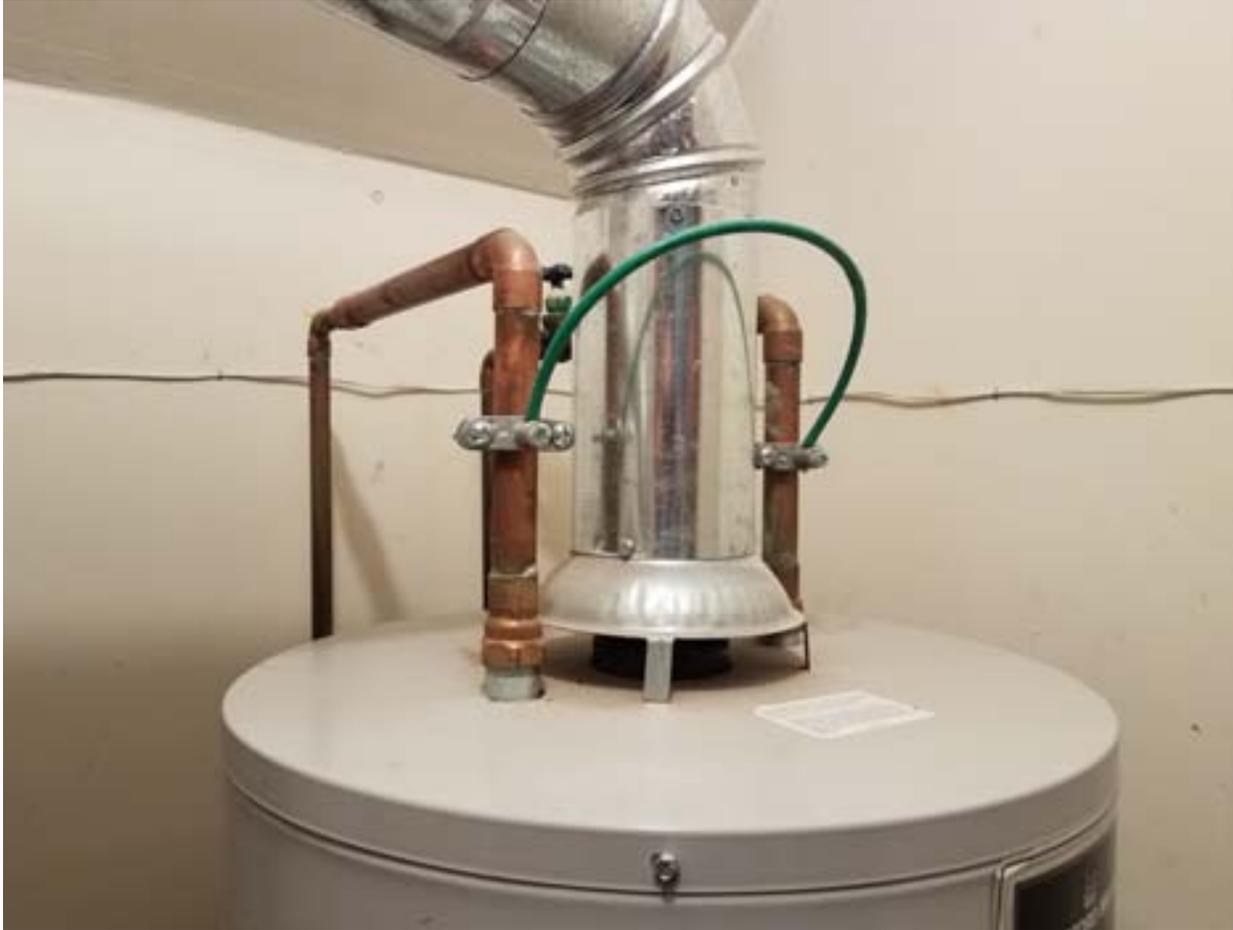
- [1C.17](#) Sump pump: Not found and is always recommended to prevent possible water damage
Water heater temperature should deliver around 120 degrees for safety, longevity and efficiency (scalding can occur from 122 degrees and up). Anti-scald valves are also recommended for all showers and tubs for safety
Jumper cable/grounding is loose and needs to be tightened to ground hot and cold copper piping for safety

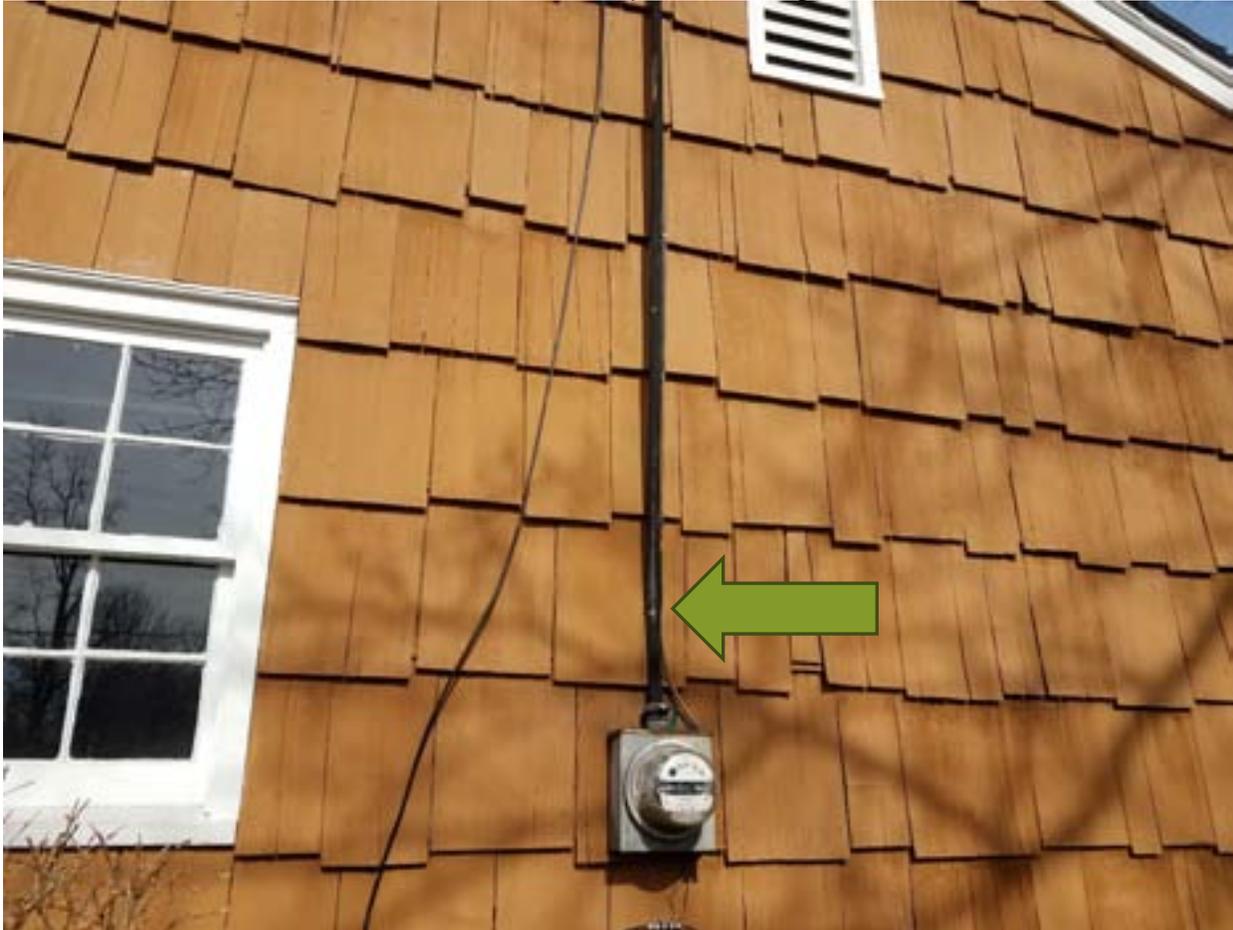
[5C.17](#) Cable not attached to structure at 4 1/2' intervals

[5C.17](#) Cable not attached to structure within 12" of box. This is a safety concern. Repair is recommended. This is a safety concern. Repair is recommended

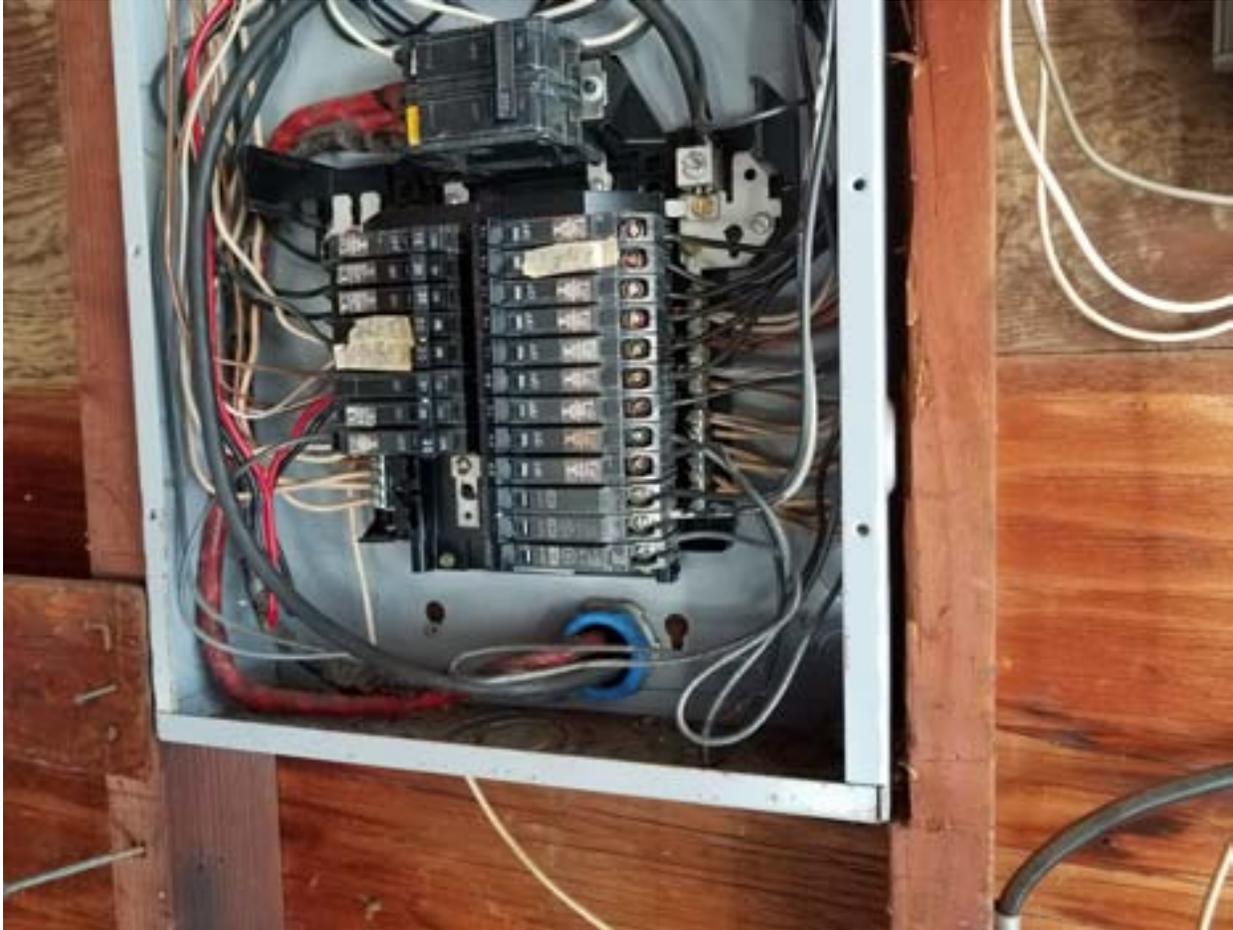
Aluminum single strand wiring was found in the panel box. This wiring is 55 times more likely to have safety issues as opposed to copper. Evaluation by a licensed electrician is recommended prior to contractual obligation. This is an expense concern

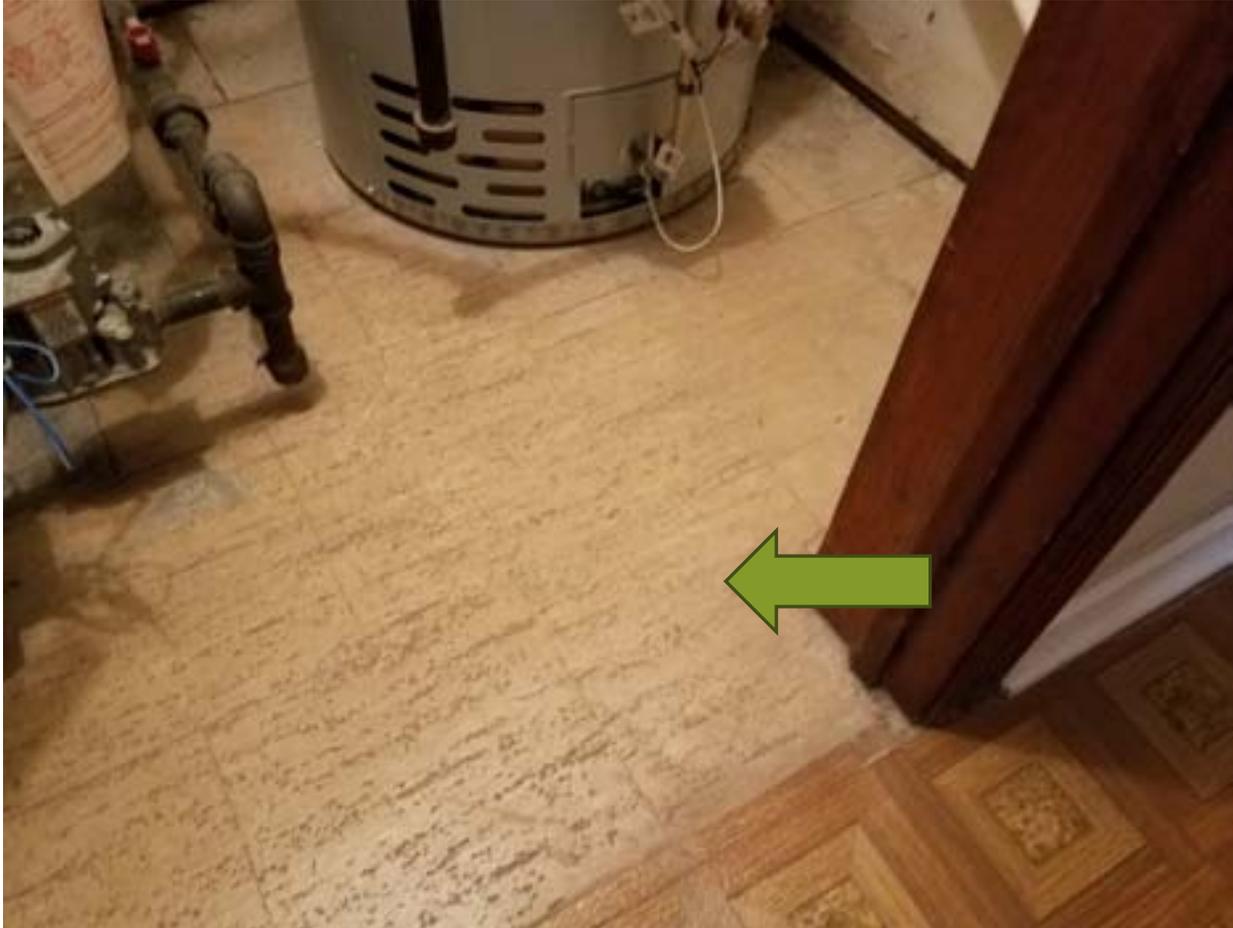
- [9A](#) Suspected, partially asbestos 9"x 9" floor tiles and/or mastic may be present. Sampling by an asbestos inspector was recommended and lab results are pending. This is a health concern

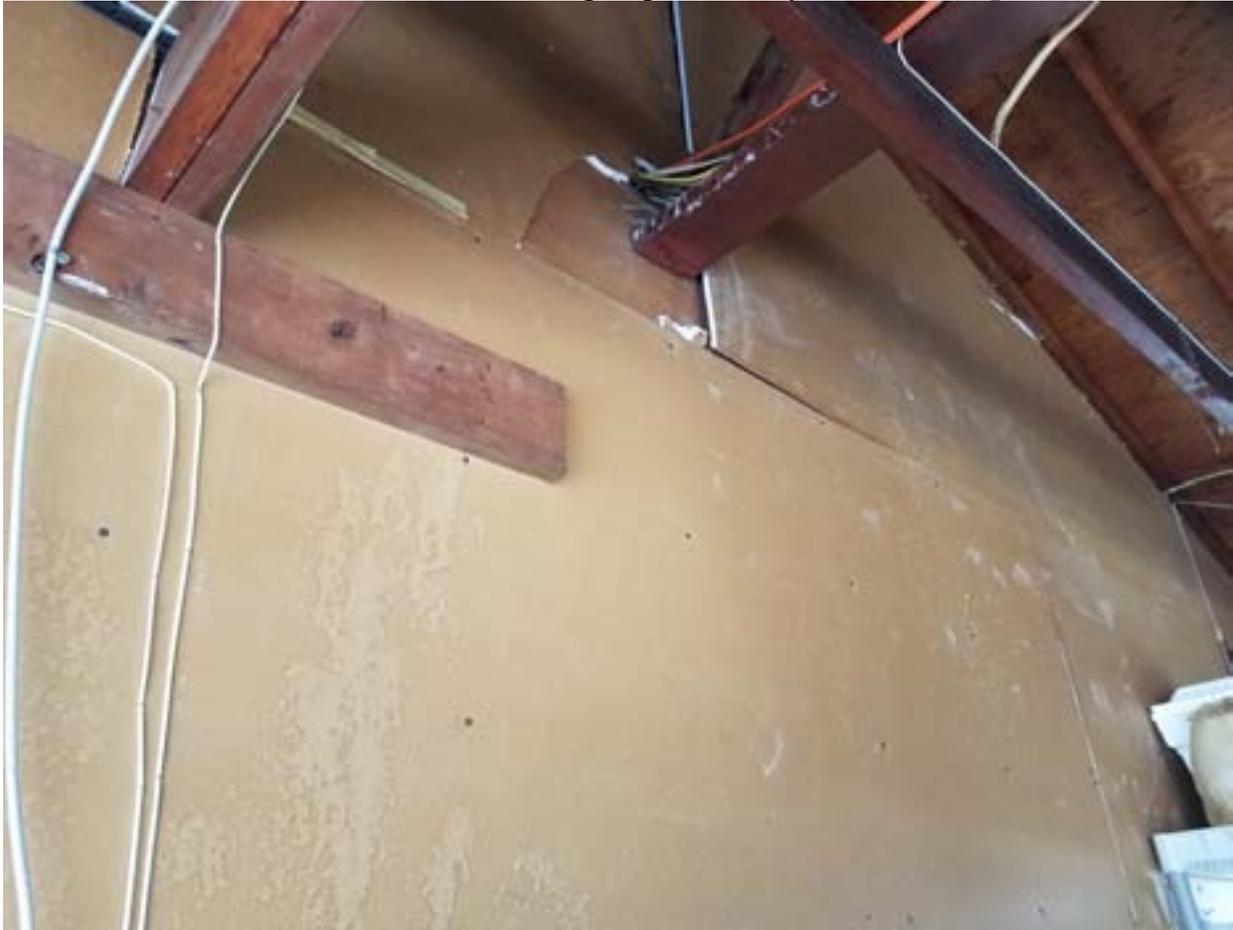
3C.34 Fire resistant wall recommended in garage for safety. This is an expense concern

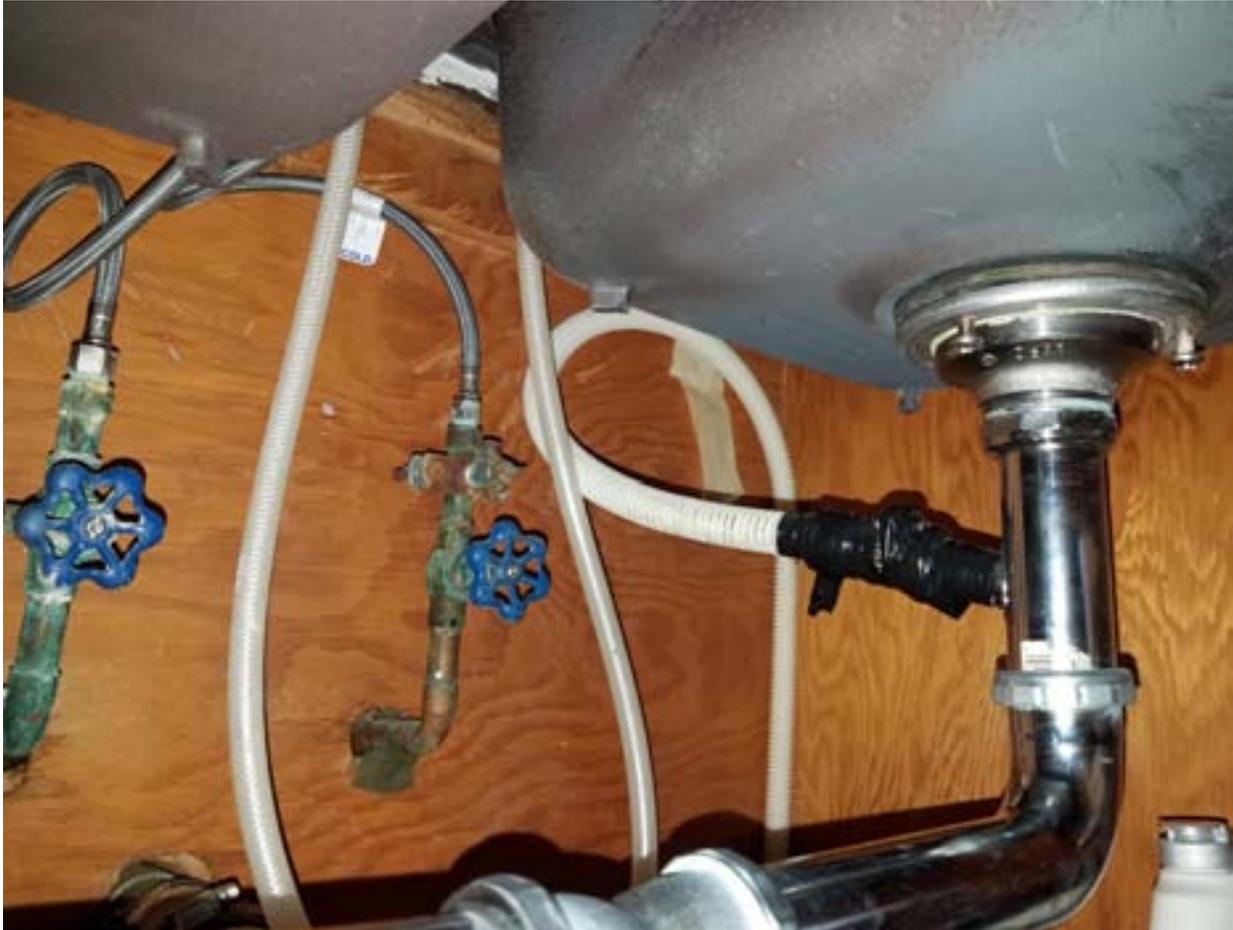
[8C.07](#) Dishwasher not secured and electrical tape of drain may indicate leak/amateur work. Repair is recommended. This is a safety concern

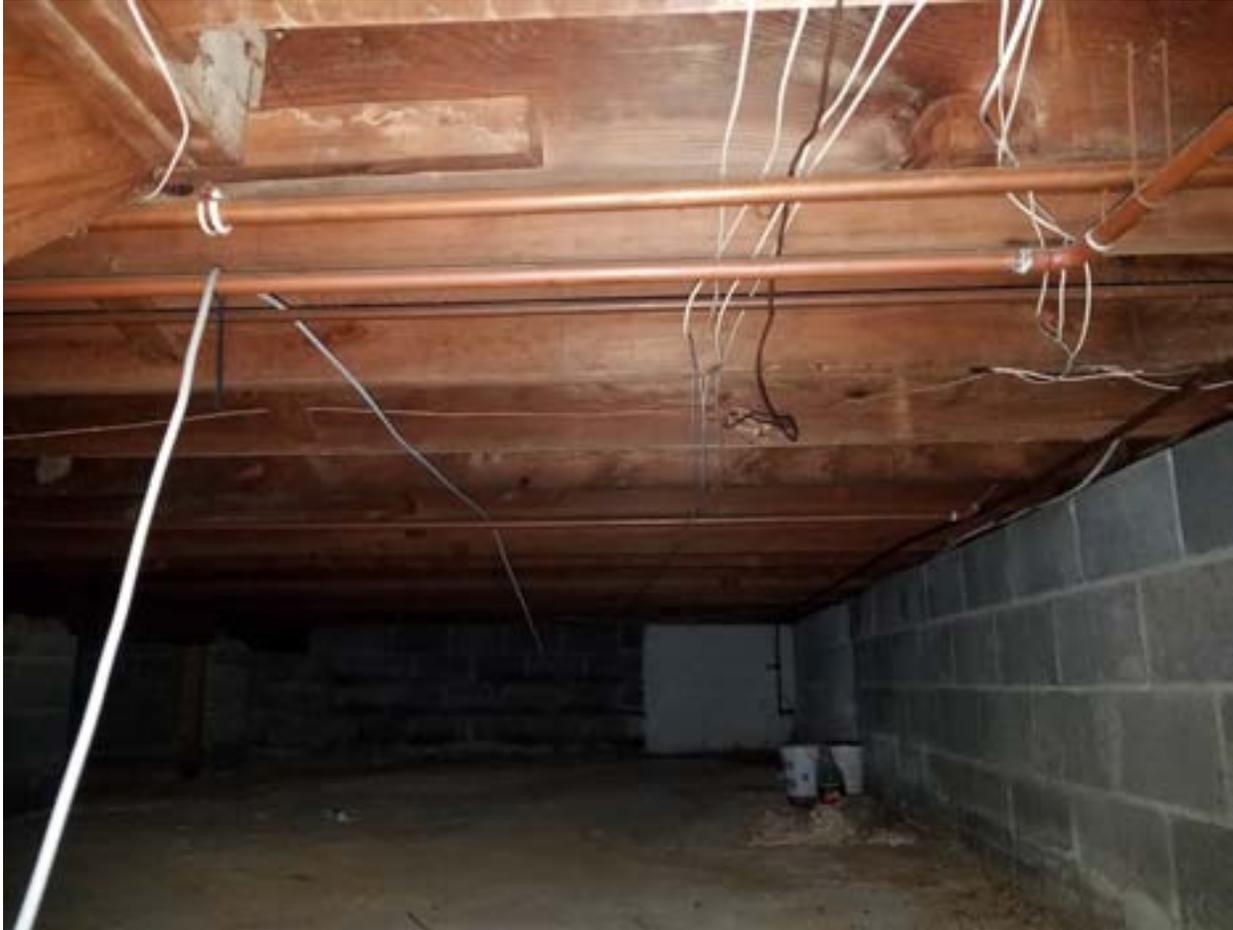
Fiberglass insulation missing under floors with crawl space below and is recommended for efficiency, health, etc
