POLO & ASSOCIATES HOME INSPECTIONS, LLC

David J. Polo Home Inspector Lic. #24GI00023700

*Survey Abstract (*Summary of Concerns*)

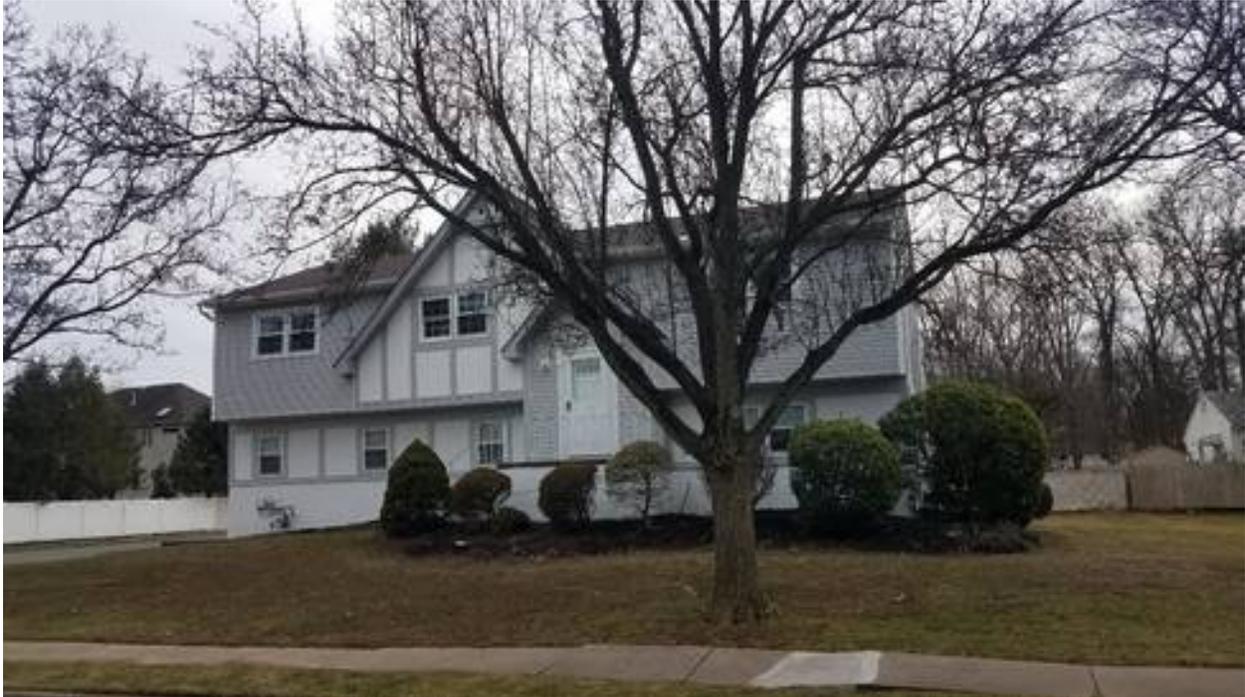
[1C.50](#) Instability/settling indicators & phenomena: typical, (within 1\8") vertical hairline/step cracks: Apply epoxy injection sealant method to cracks on both sides and monitor for continued movement. If cracking persists contact a structural engineer; sag/creep likely; sag/settling/shrinkage/partitions offset from structure below likely

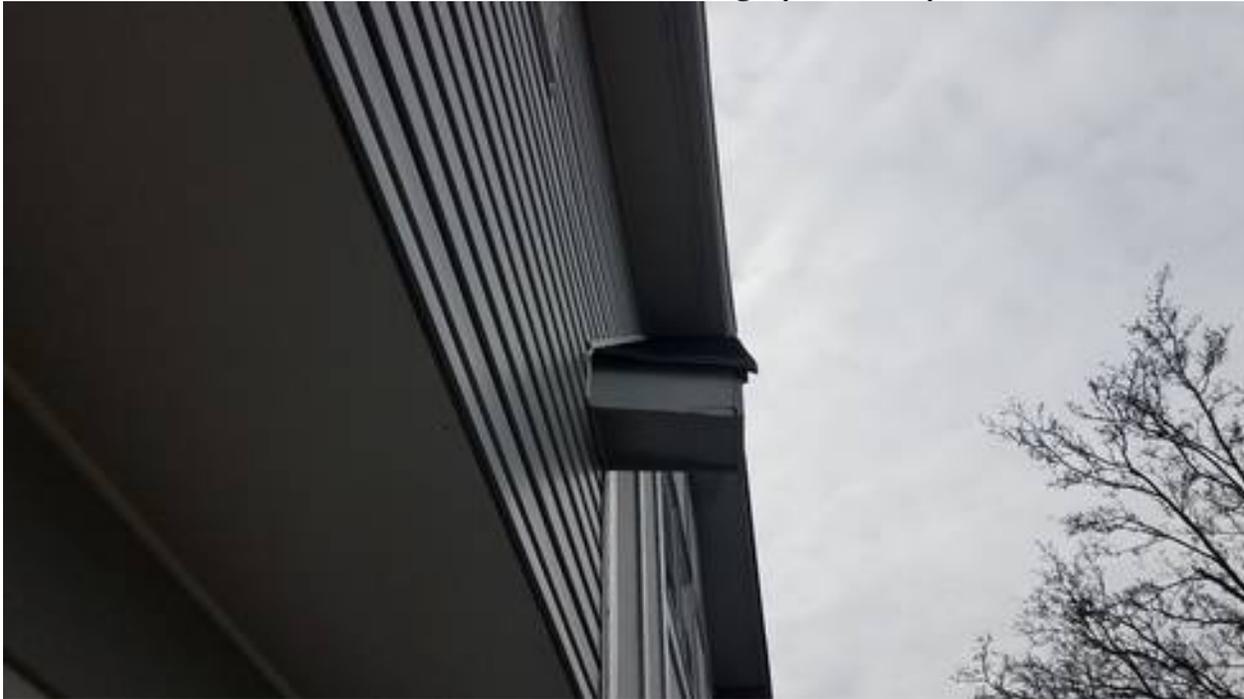
[1C.34](#) **Structural movement for front "lookout" rafters sagging/pulling off dwelling. Repair is recommended for structural integrity and safety**

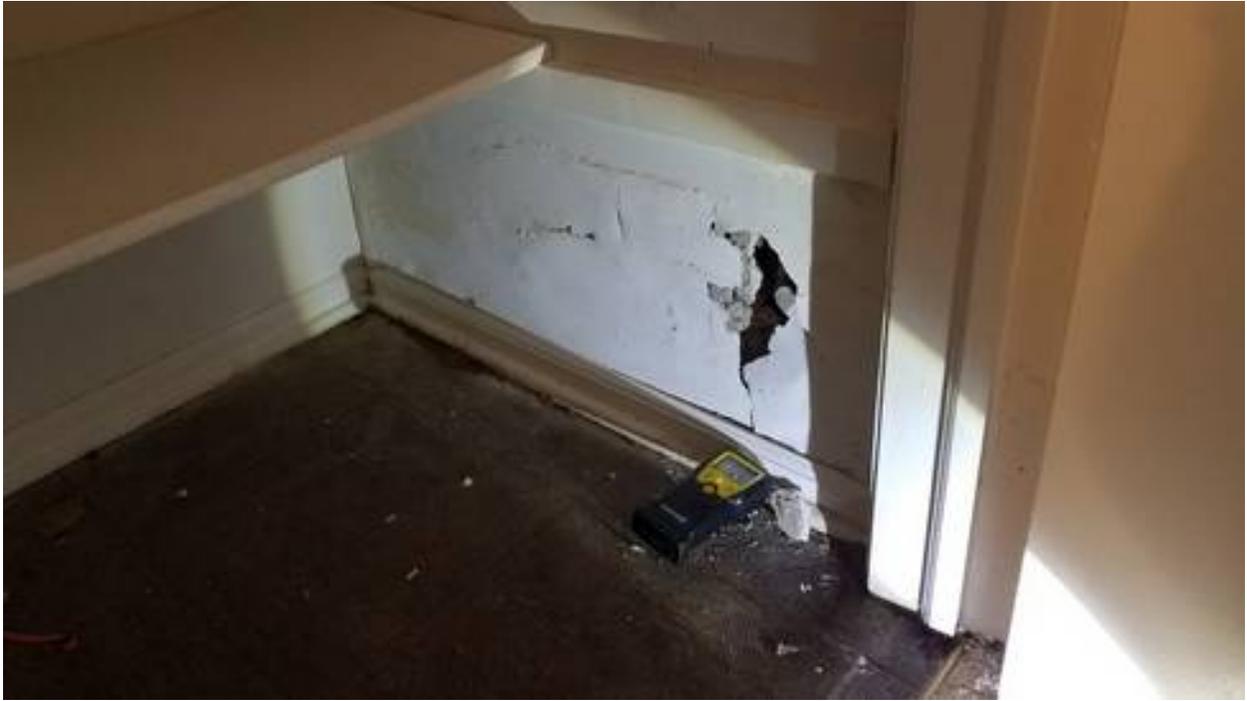
[1C.18](#) Structure/foundation moisture indicators and phenomena: Painted walls/floors may be concealing possible deterioration or chronic water intrusion conditions, termite mud tunnels, etc. Consult sellers as to any moisture/insect issues; moisture in finished basement walls (moisture metered) throughout front is active; water damage found from flooding; efflorescence; moisture meter indicates moisture; moisture penetration from outside through foundation wall; moisture visible; mold like substance front basement closet on the right side; stains visible wet to touch in basement & in foundation walls. Remove sheet rock assess and correct. This affects habitability. This is a safety concern. This is a health concern

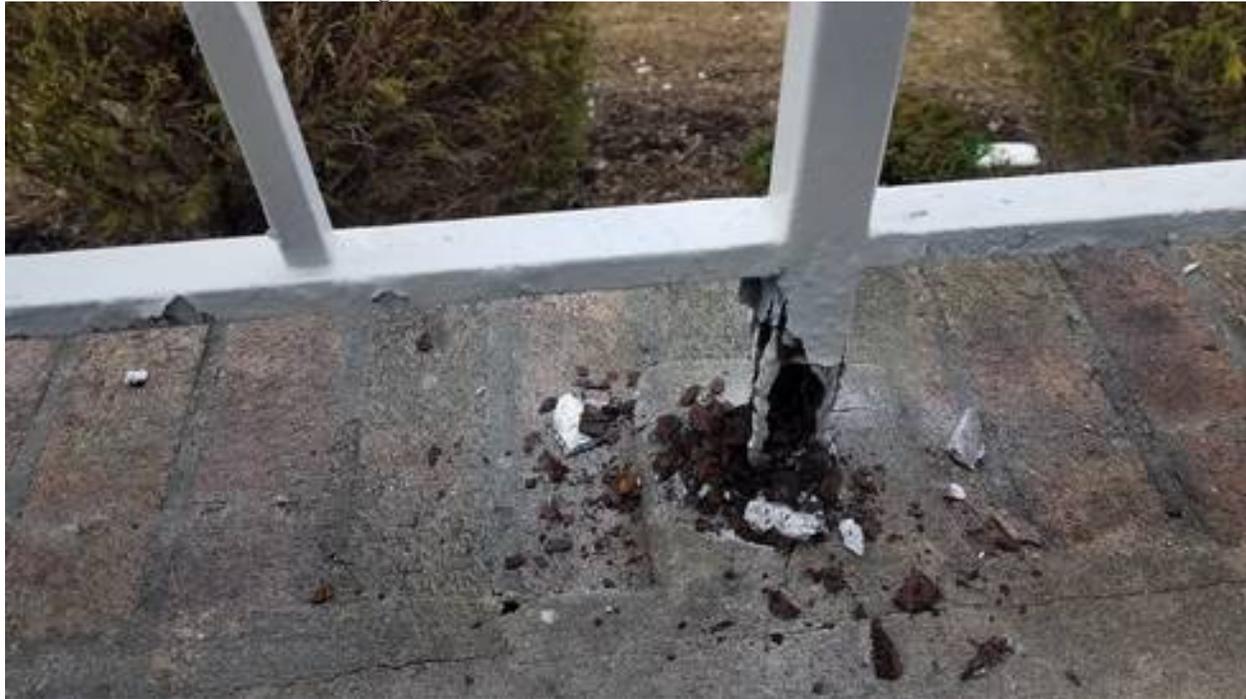
2C.02 Ironwork (handrails/guardrails) rusting through, loose and in need of replacement for safety on the right side and at the front

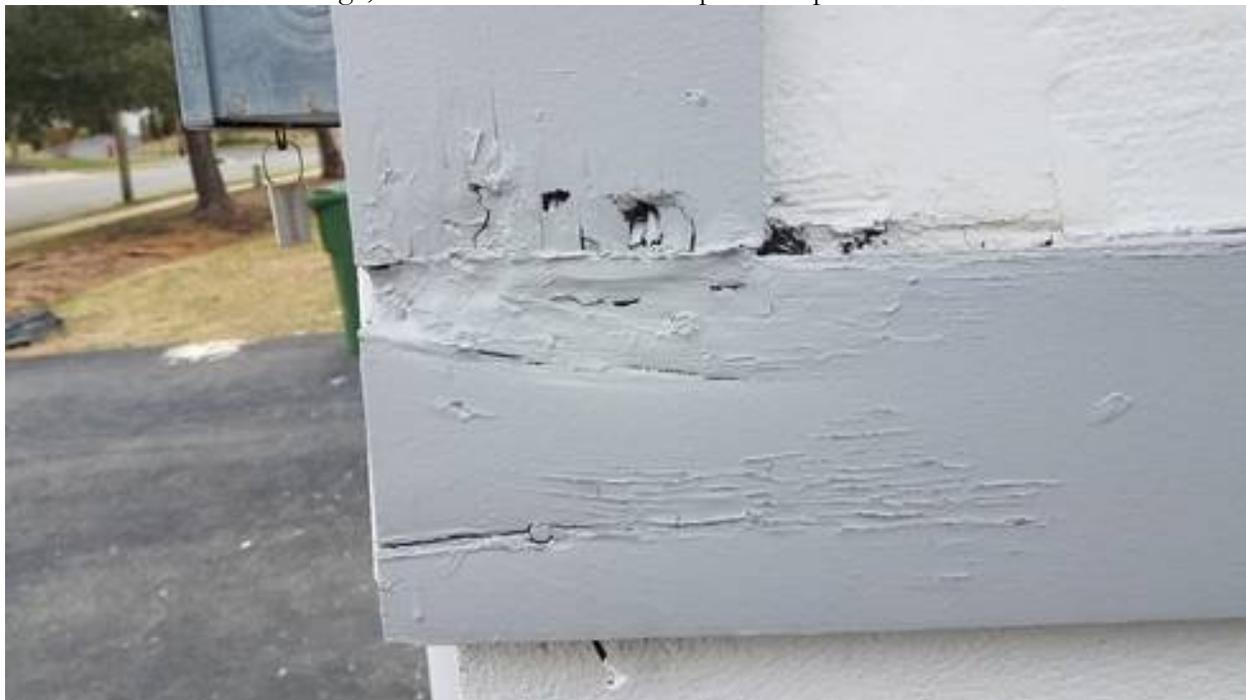
2P Paint appears to be relatively recent and is concealing rot, insect damage, mold, water damage, etc. Recommendation: Repair or replace

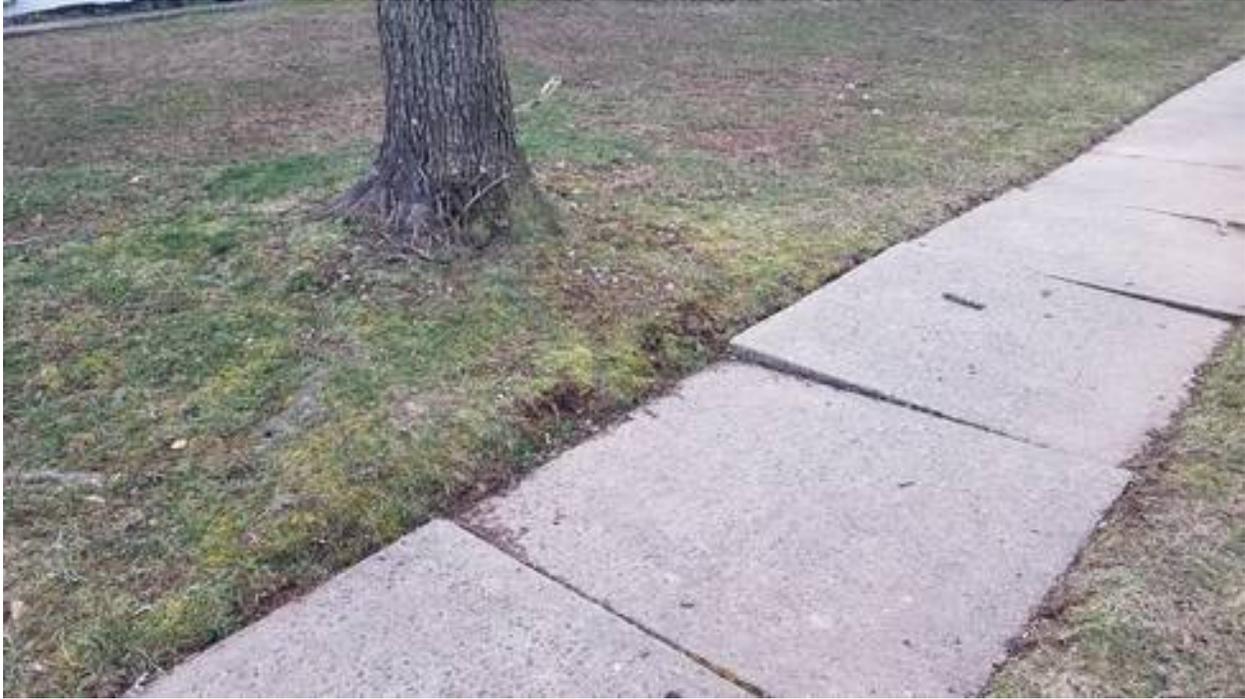
- [1S.16](#) Sidewalks/rear patio possible trip hazard due to settling/heaving (from tree roots?).
Recommendation: Repair or replace and consider tree removal. This is a safety concern. This is an expense concern

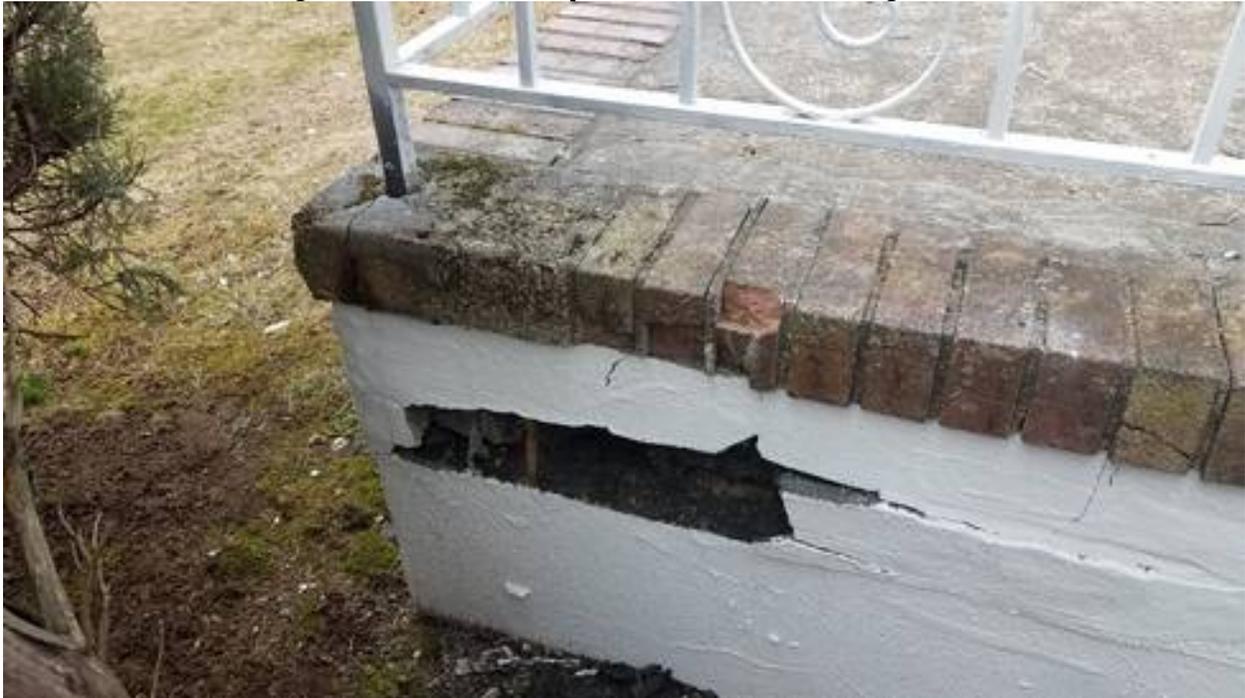
- [1C.31](#) Stoops deteriorating on the right side and at the front. Recommendation: Repair or replace. This is a safety concern. This is an expense concern

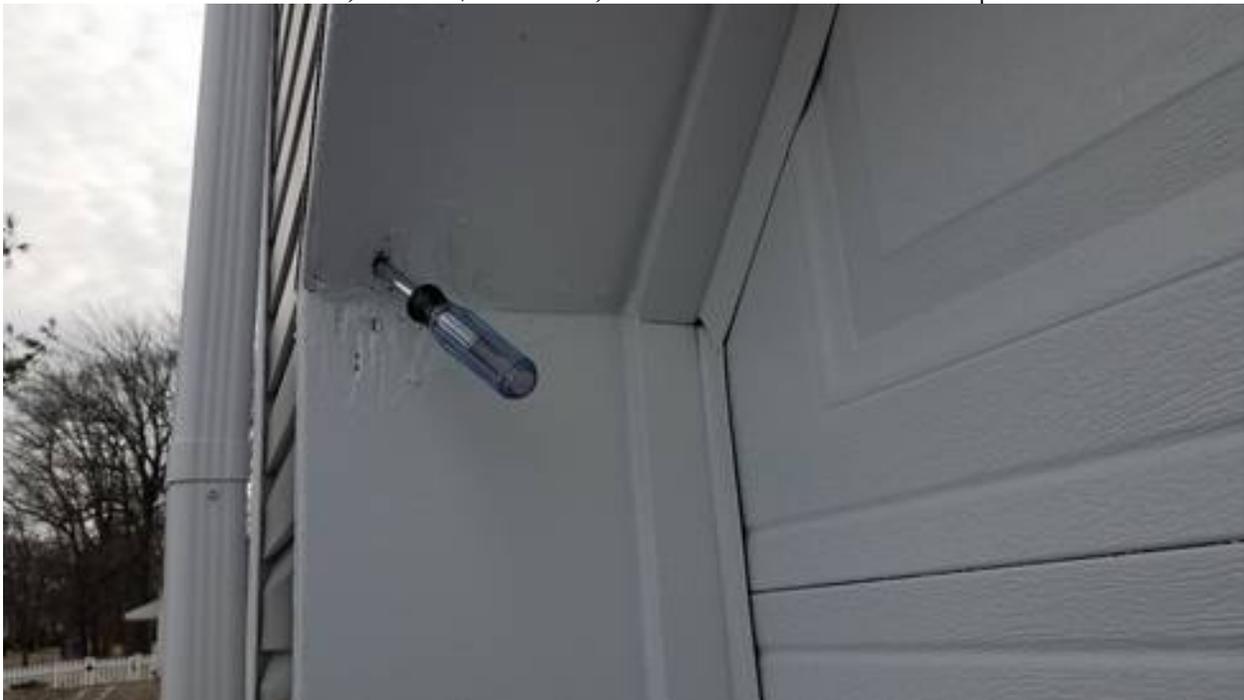
- [1C.06](#) Wood rot, many areas (covered by fresh paint, putty, caulk, spackle, etc.) such as roof trim, soffits, window/door trim, etc. etc. Recommendation: Replace

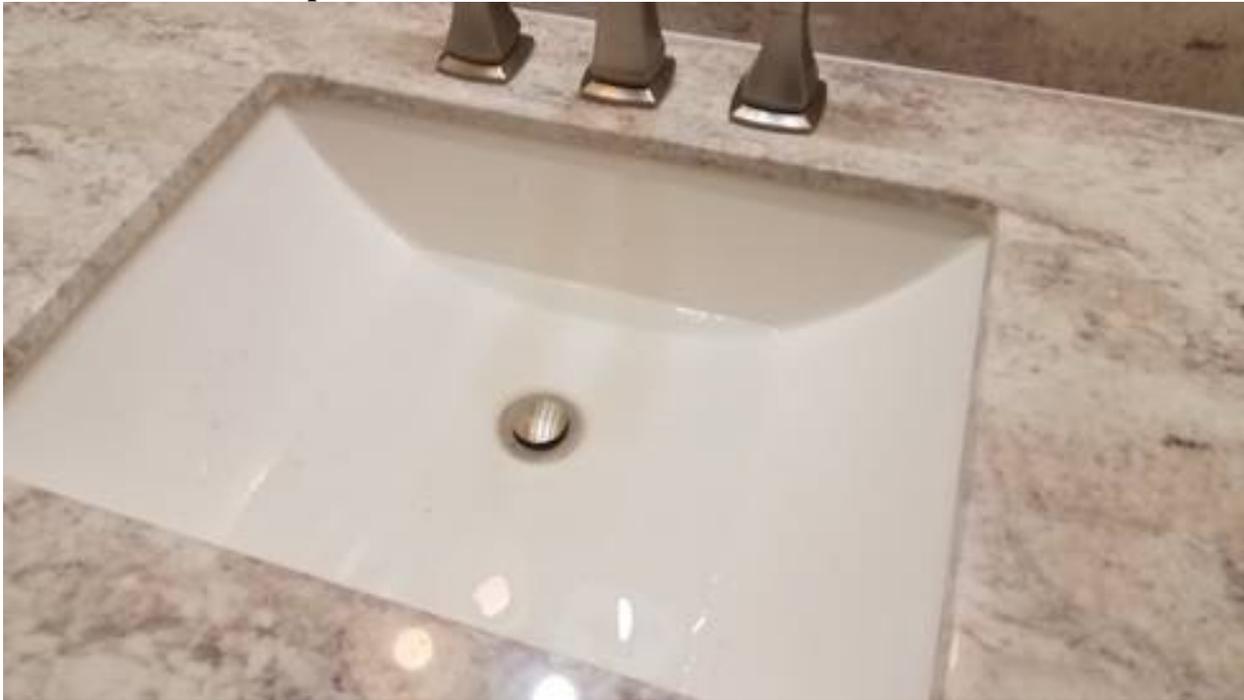
4C.05 Drain does not properly drain: sluggish/clogged/stopped up in the hall bathroom. Repair is recommended

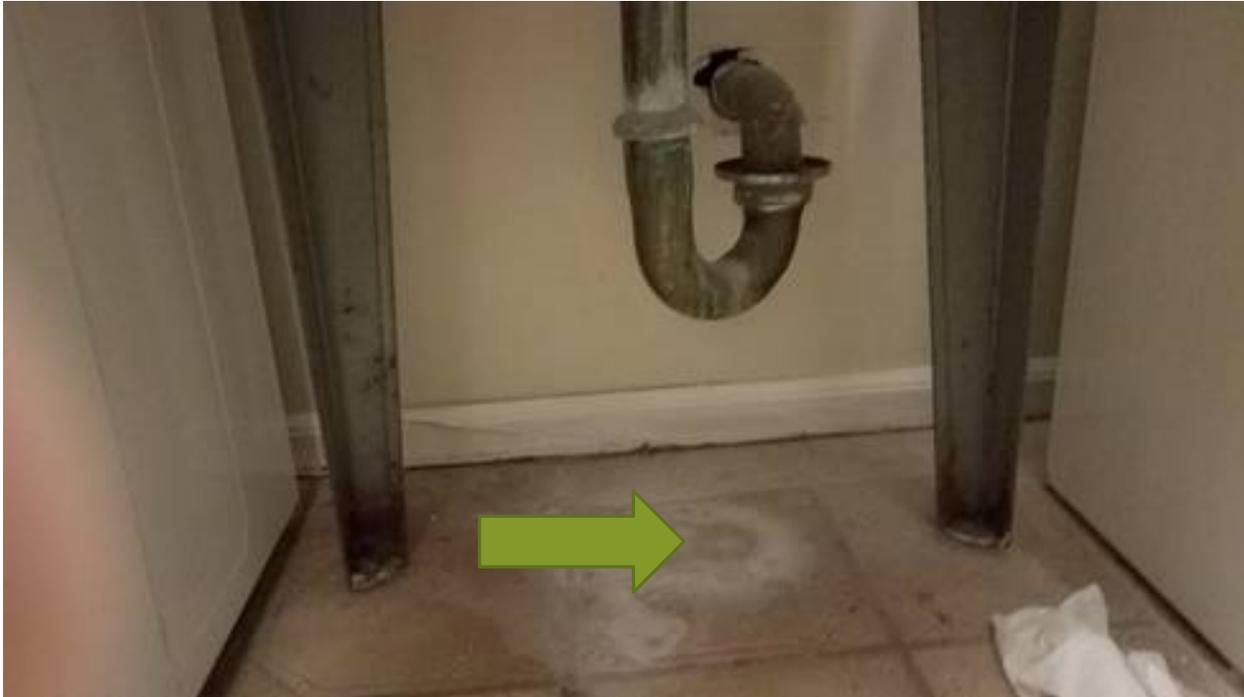
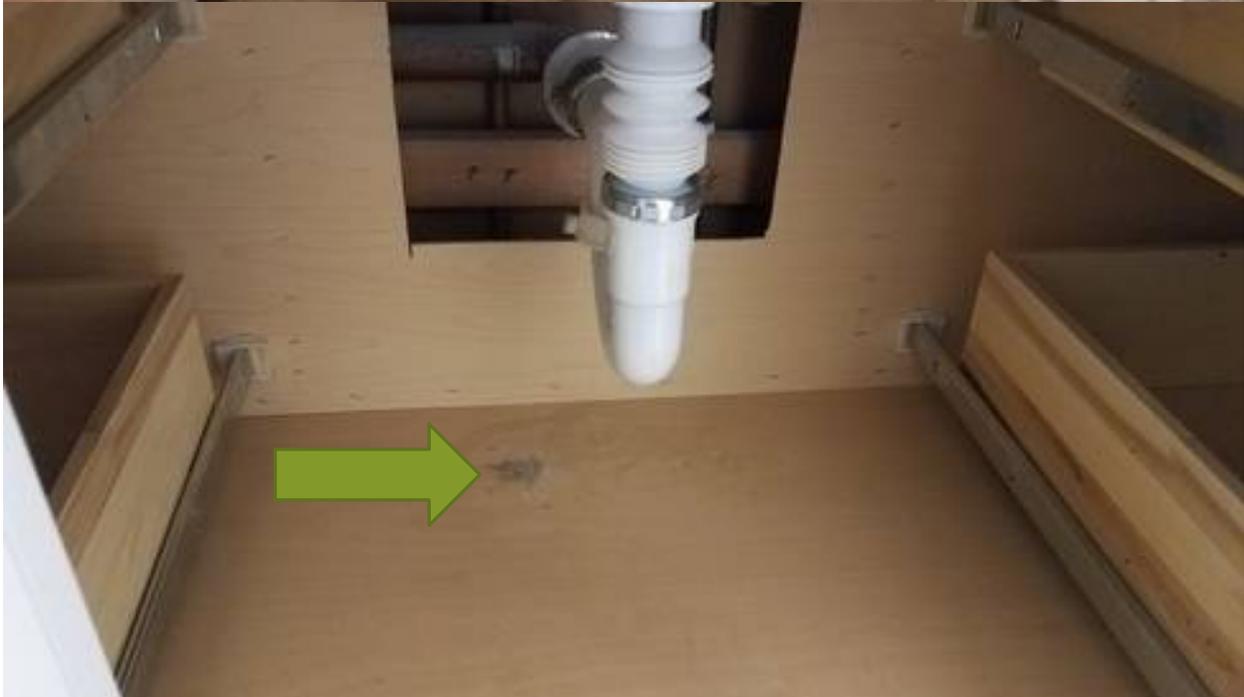
4C.01 Leak, water: laundry tub drain and hall bath sink drain. Recommendation: Repair or replace. This is a safety concern

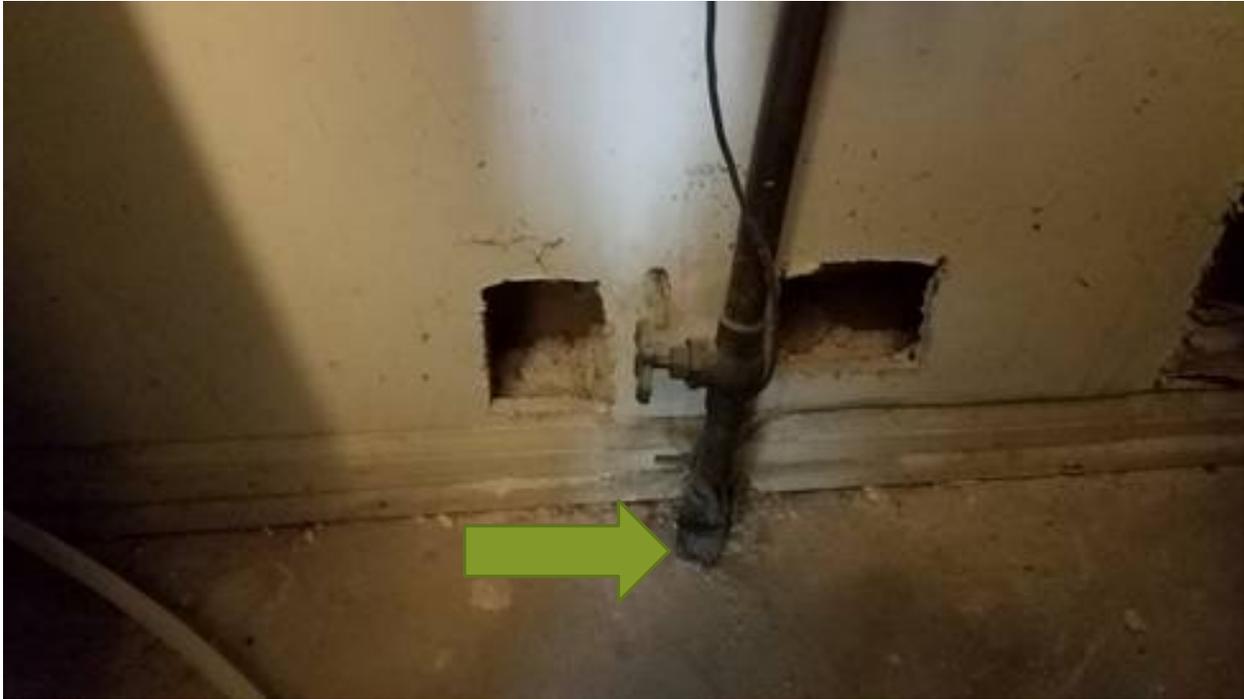
[4C.21](#) **Deterioration can and perhaps already has occurred (cut out in many areas) in copper piping that is in direct contact with concrete. This is an expense concern. Recommendation: Monitor and budget for future functionality or repair**

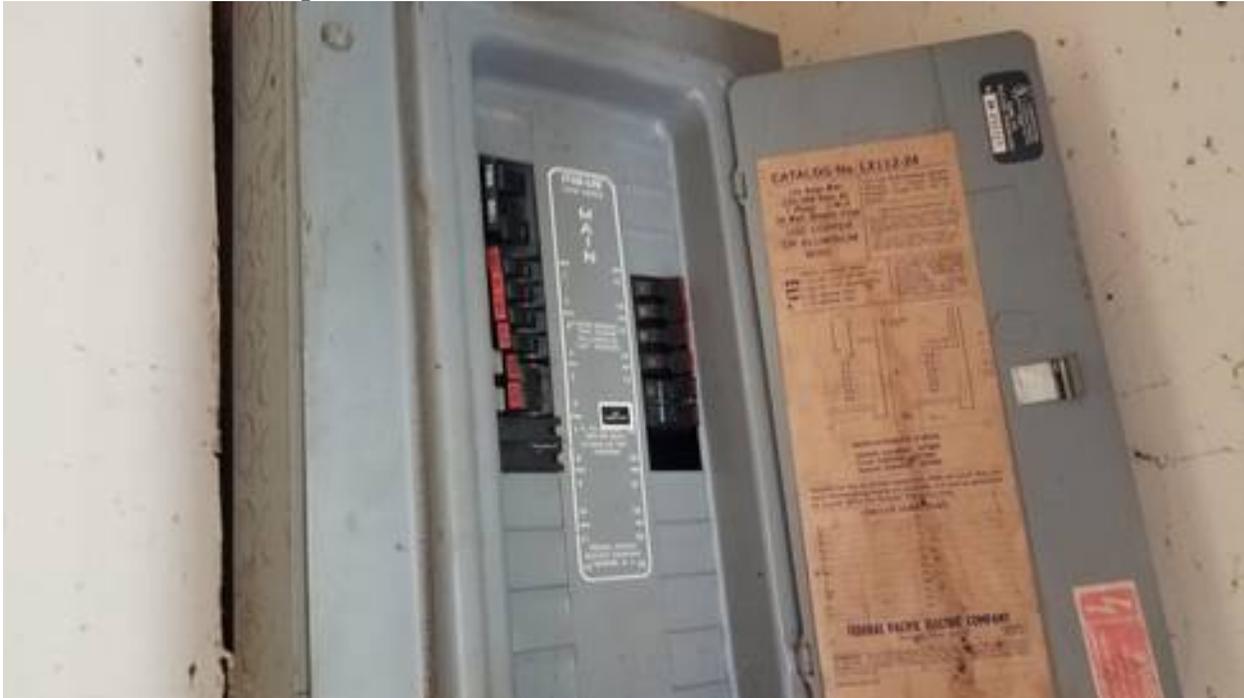
[5A.00](#) FPE "Stab-Loc" panel boxes tend to be unreliable/unsafe, especially if made before 1985. This is a safety concern. Evaluation by an electrician is recommended/replacement prior to contractual obligation. This is an expense concern

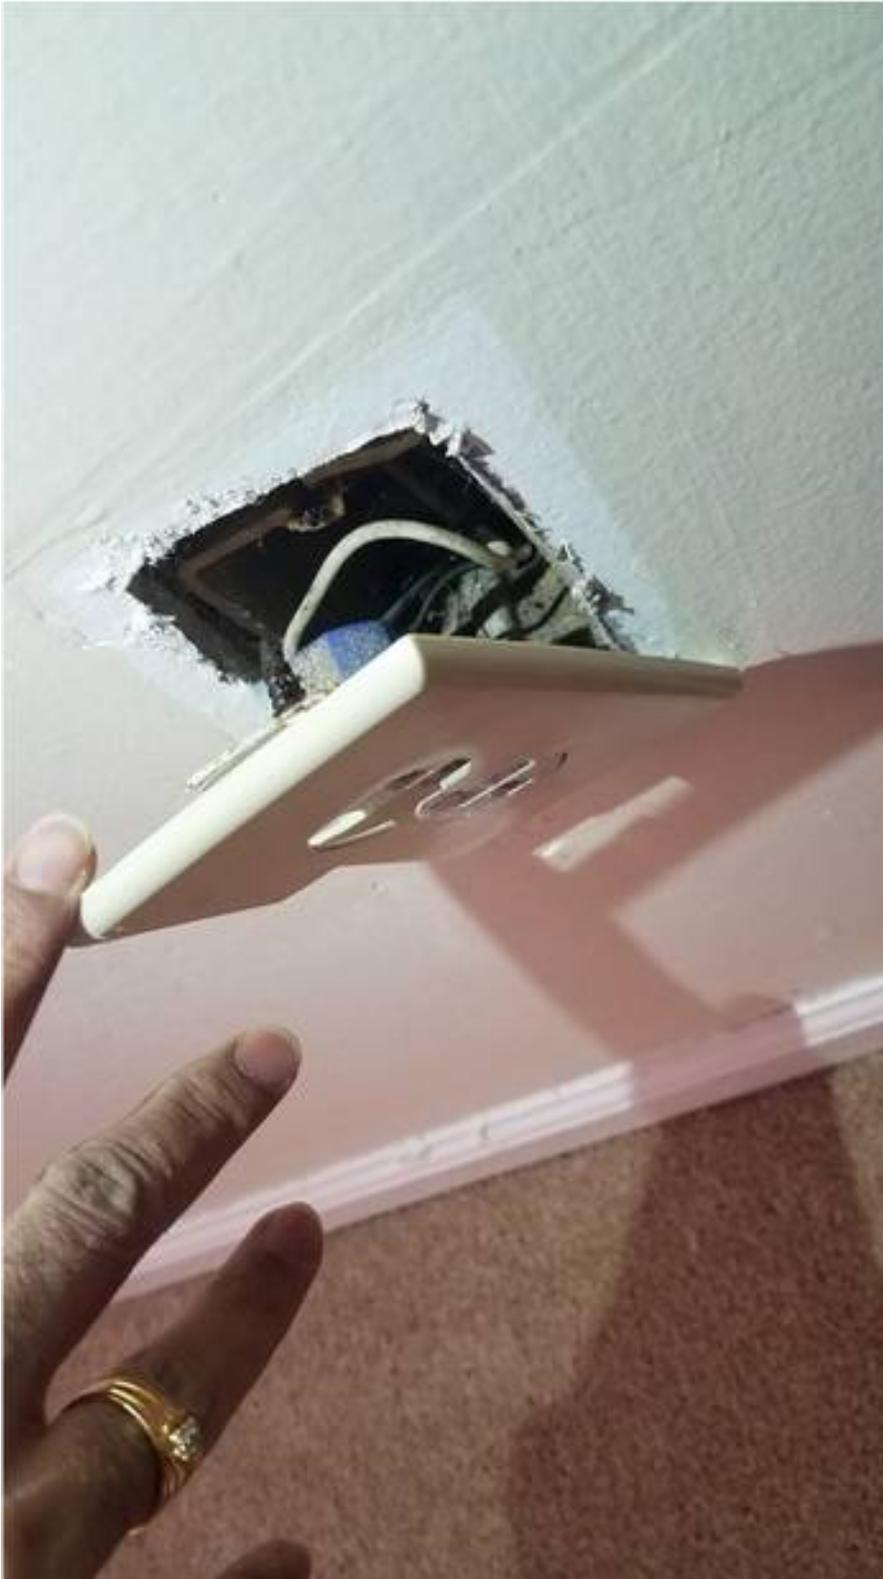
[5C.59](#) Receptacle/wiring water damaged in the basement at the front. Recommendation: Replace. This is a safety concern

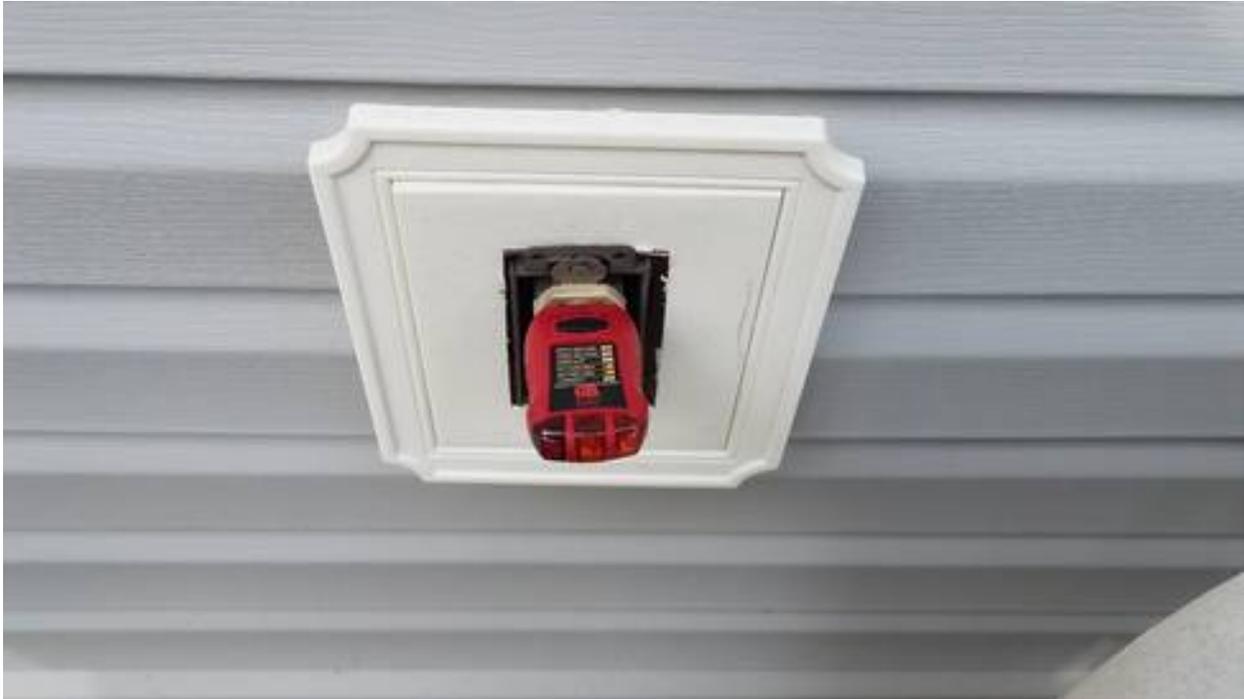
[5C.59](#) Receptacle apparently dead and missing cover plate outside at the rear. Recommendation: Replace. This is a safety concern

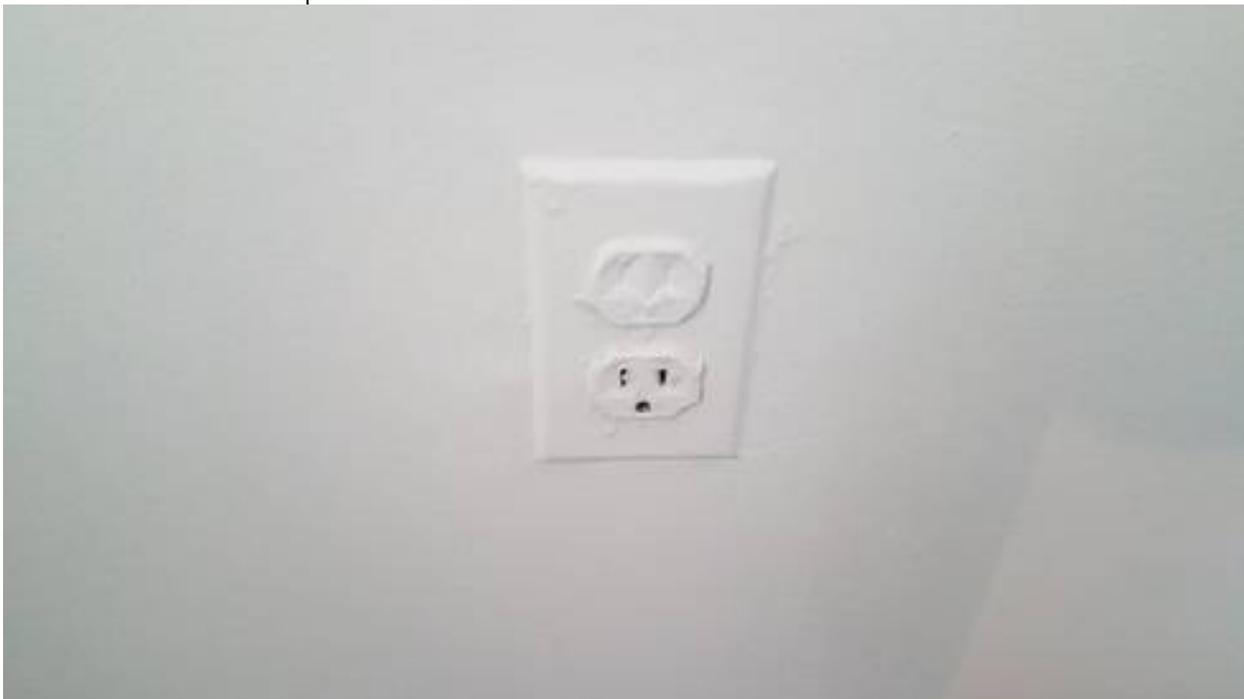
[5C.64](#) Receptacles: painted many areas. This is a safety and function concern. Recommendation:
Replace

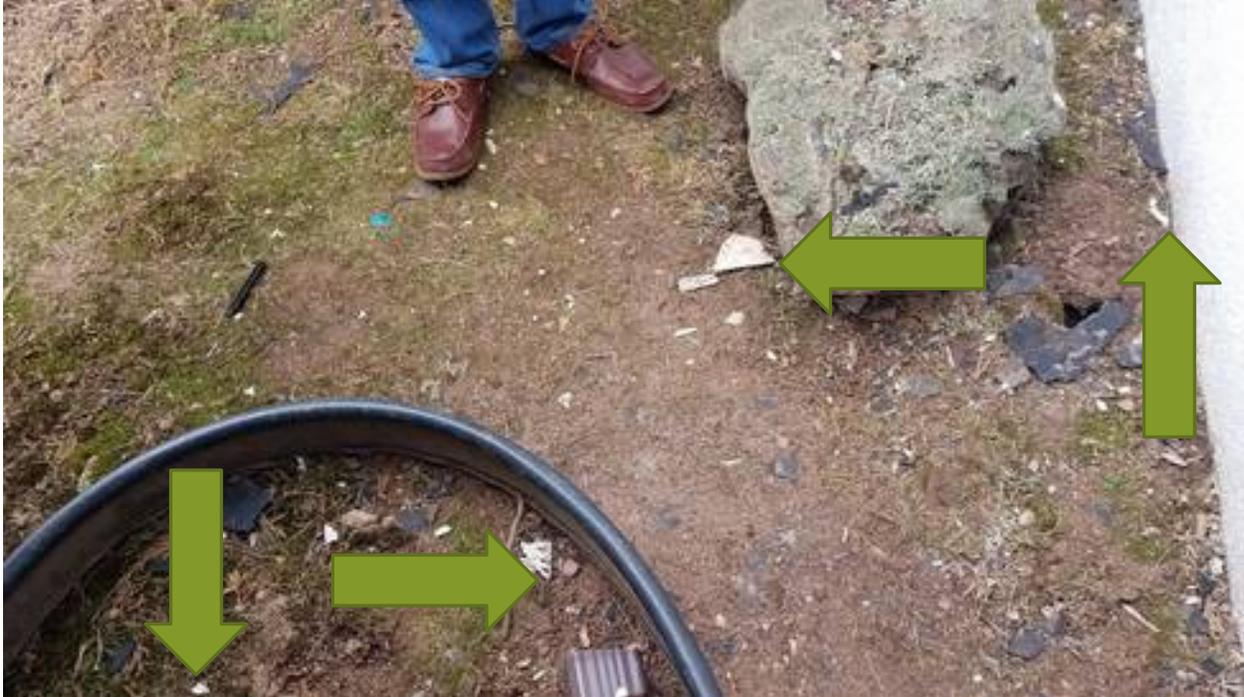
Siding debris found all around exterior may contain asbestos. This is a health concern. Sampling by an asbestos inspector was recommended and lab results are pending

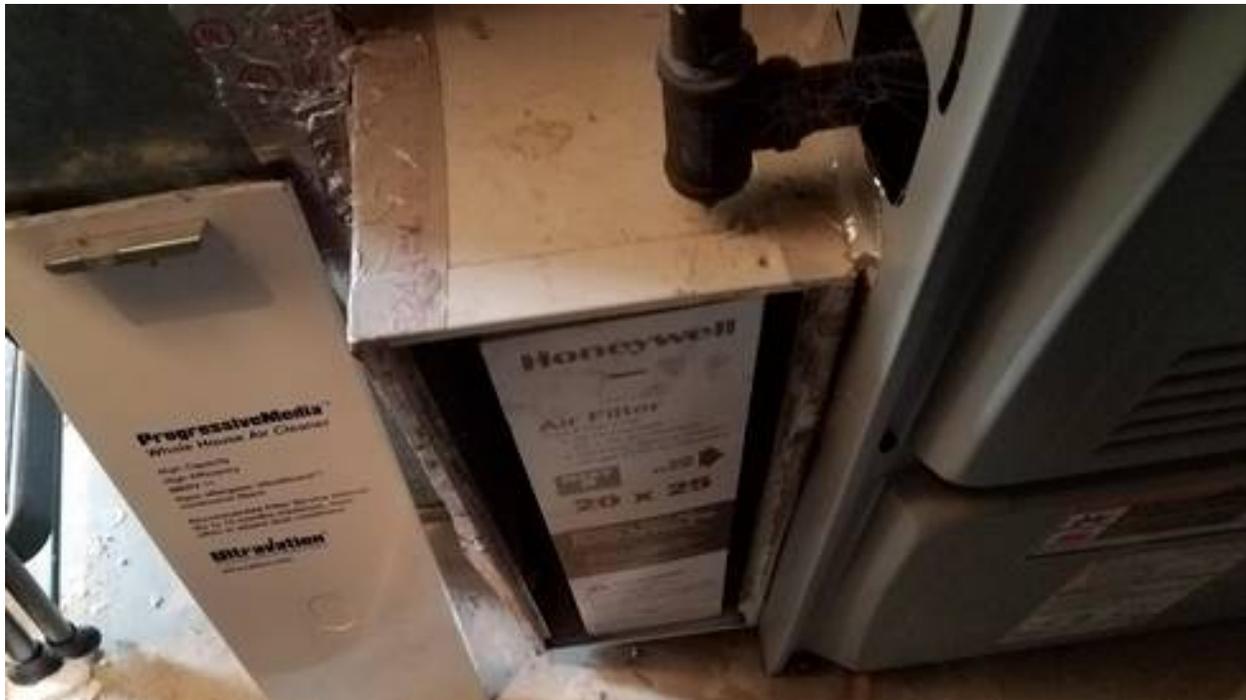
[6C.01](#) Filter not snug. This is a health concern. Repair is recommended

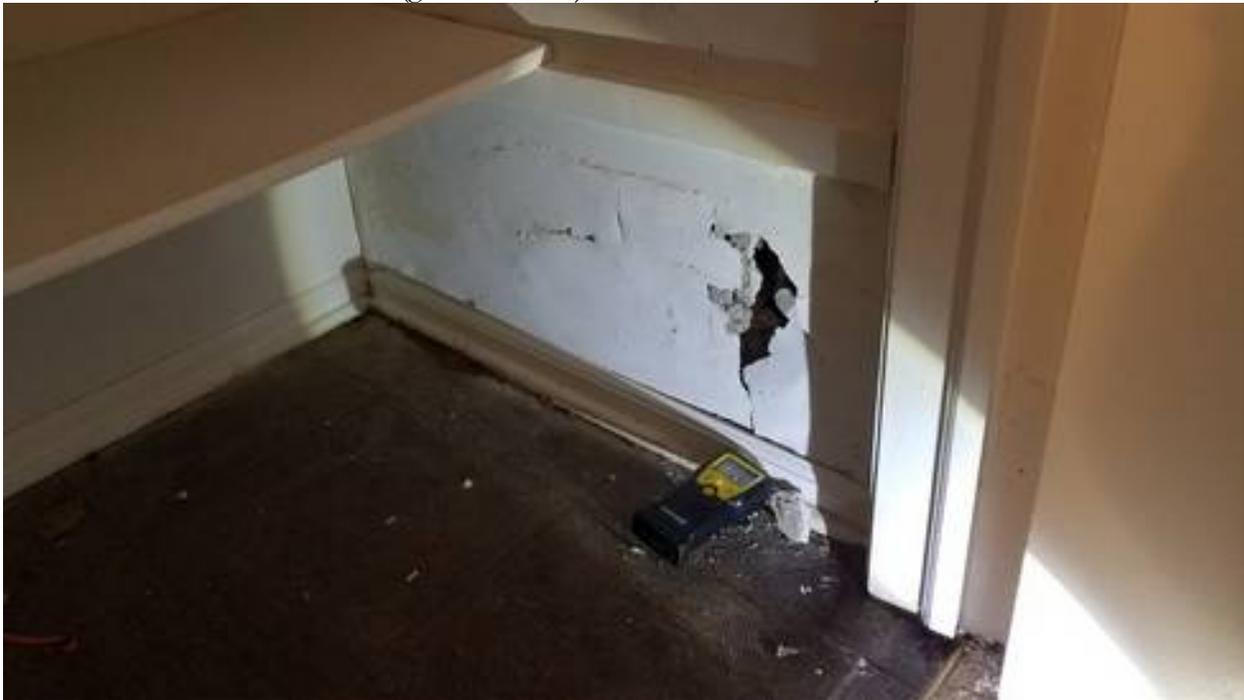
Damaged/moldy wallboard in the basement at the front should be tested, then remediated for health (gut as needed). This affects habitability

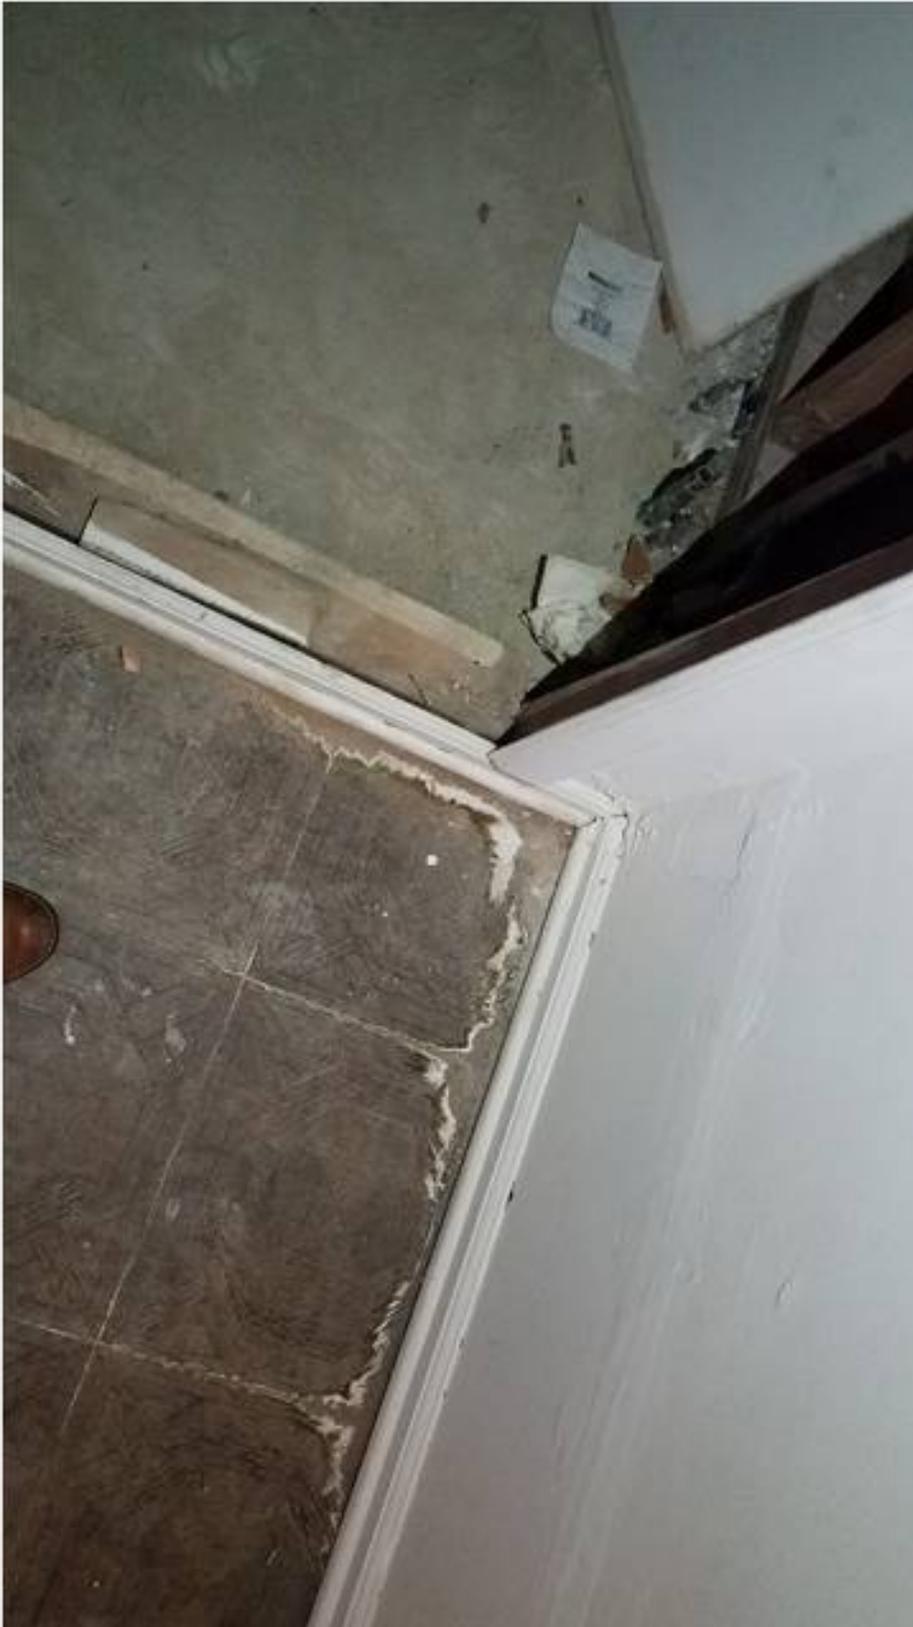
7C.13 Ceiling/wall/floor stains, patches and cut out sheet rock at many areas likely indicate previous moisture/leaking/burst piping/flooding. Stains are presently dry according to moisture meter. Open up ceiling to assess/consult seller for explanation and monitor for future activity

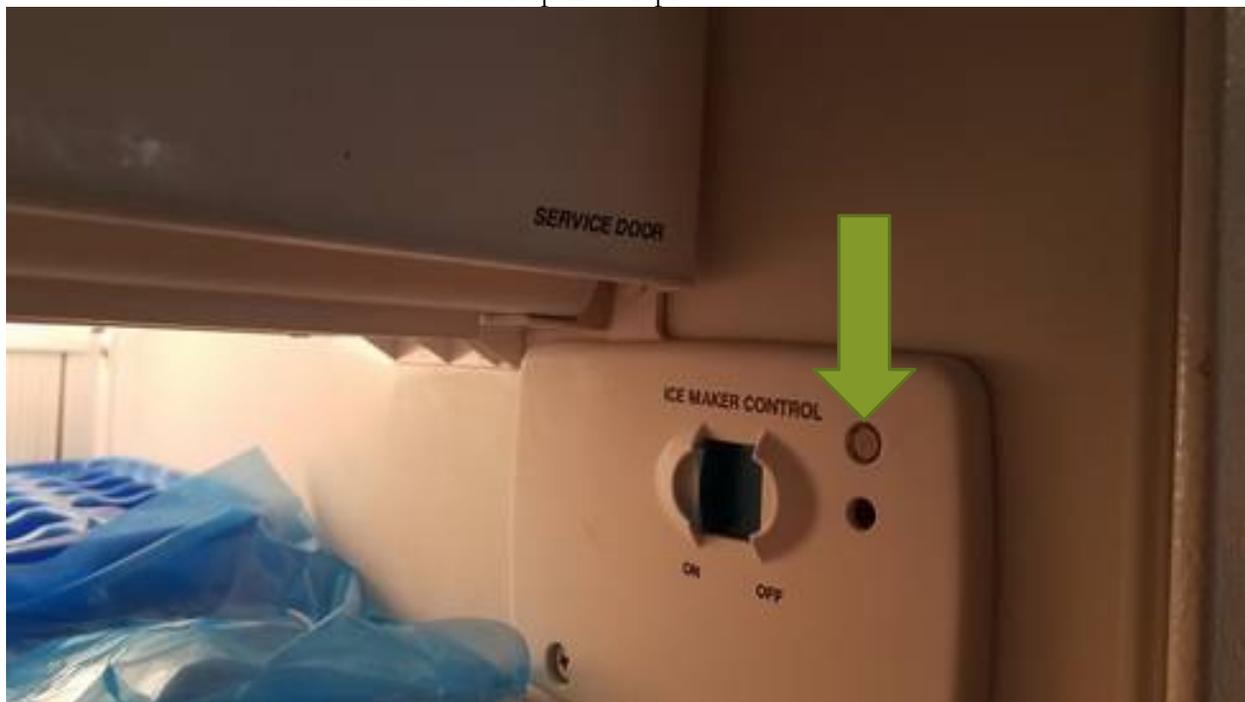
[8C.14](#) Refrigerator: ice maker not operational and water dispenser poorly plumbed.
Recommendation: Repair or replace

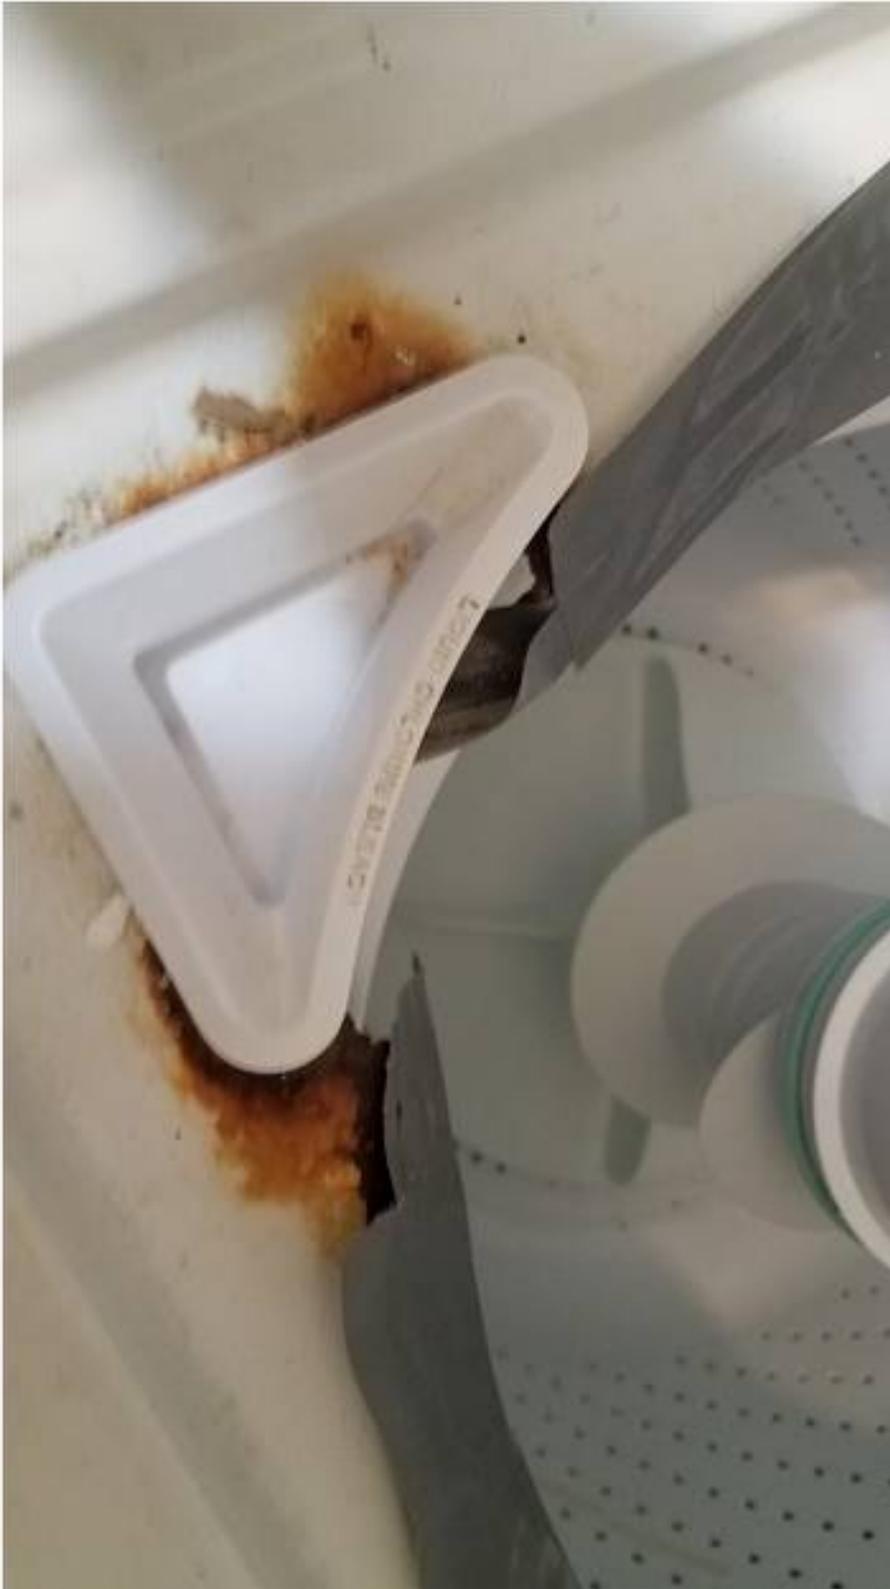
[8C.17](#) **Washing machine rusted through and duct taped. Recommendation: Replace**

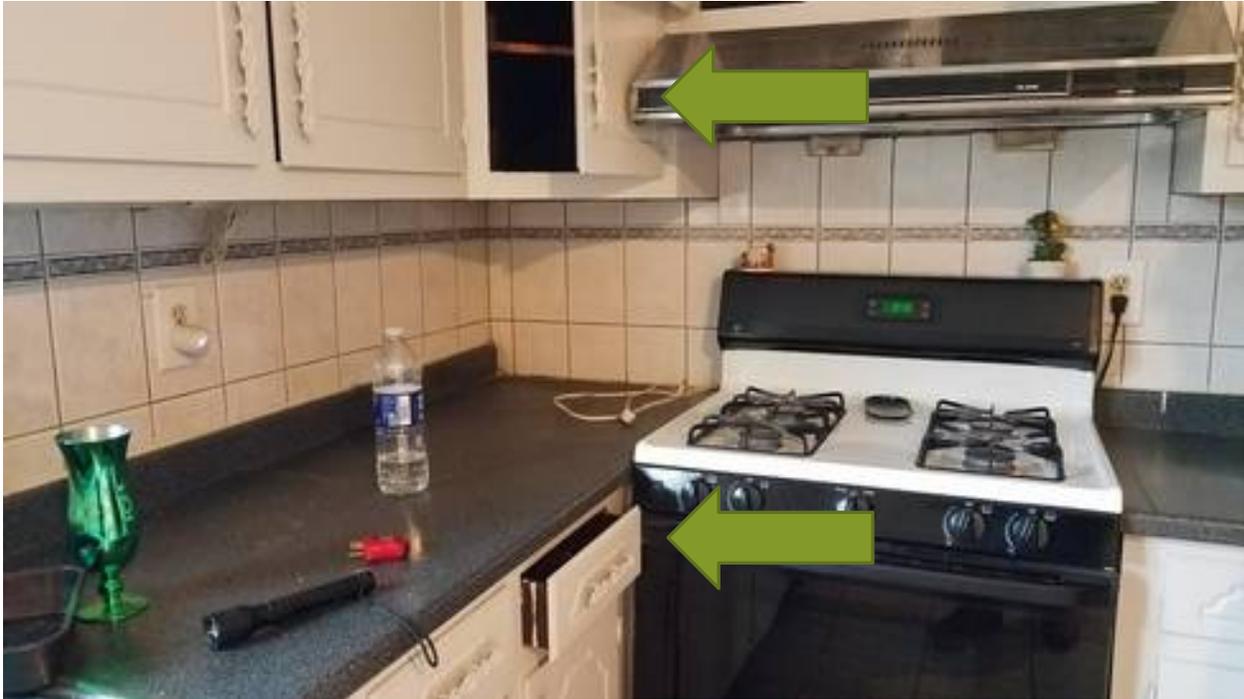
[8C.02](#) Cabinetry doors and drawers cannot open properly especially around oven. This is amateur or unprofessional work. A specialist should reinspect the entire system and correct other unprofessional work that may be found. Repair is recommended
