POLO & ASSOCIATES HOME INSPECTIONS, LLC

David J. Polo Home Inspector Lic. #24GI00023700

*Survey Abstract (*Summary of Concerns*)

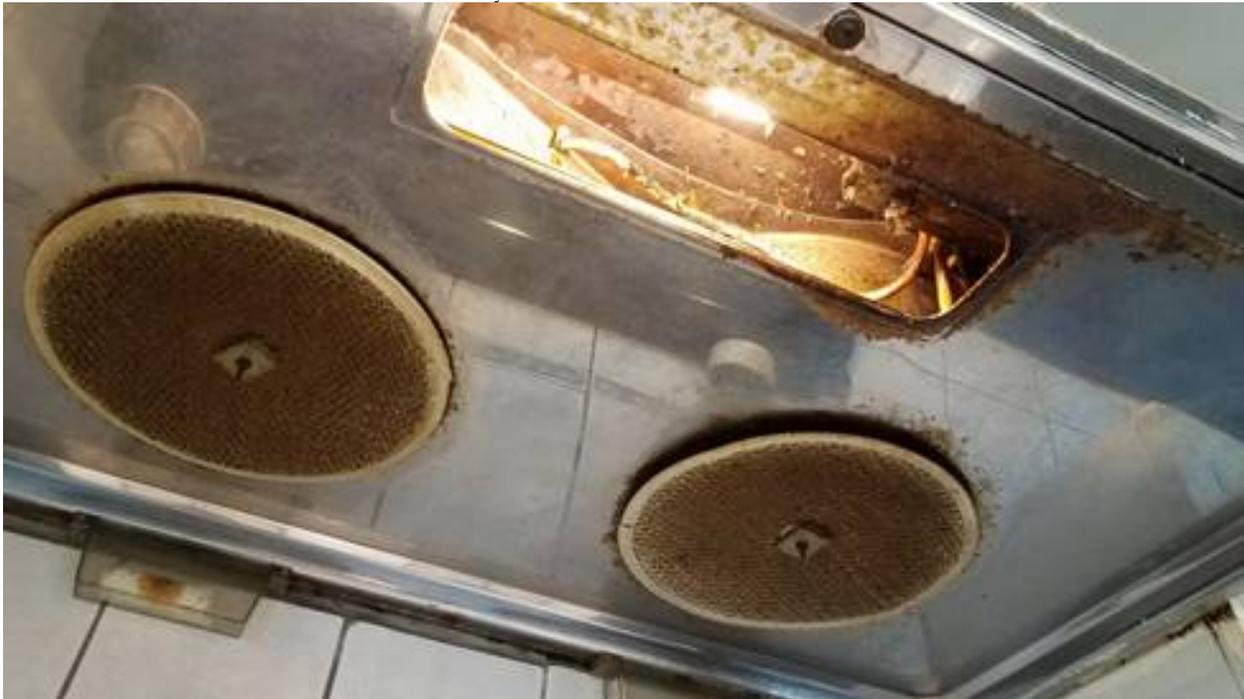
[9E.20](#) Insulation comparative rating: fair-r-13-19
Filters and hood grease laden for kitchen exhaust fan. Recommendation: Replace for function and safety

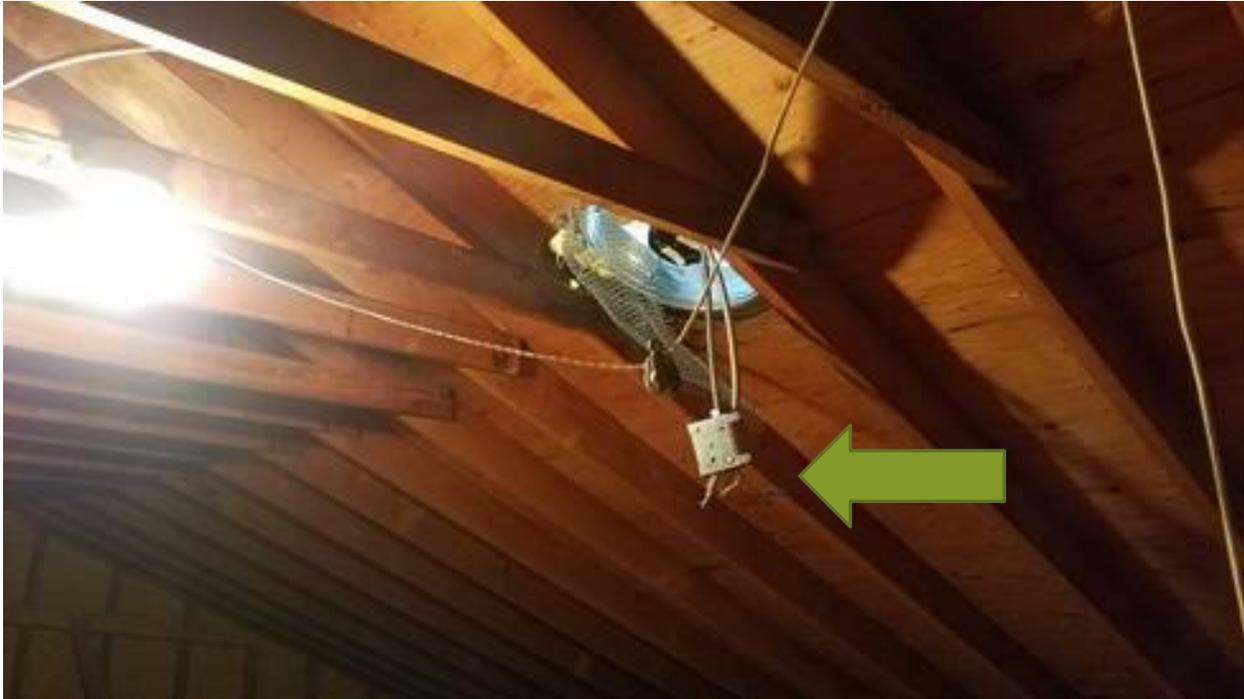
[5C.36](#) Attic vent fan not wired and not working. Recommendation: Repair

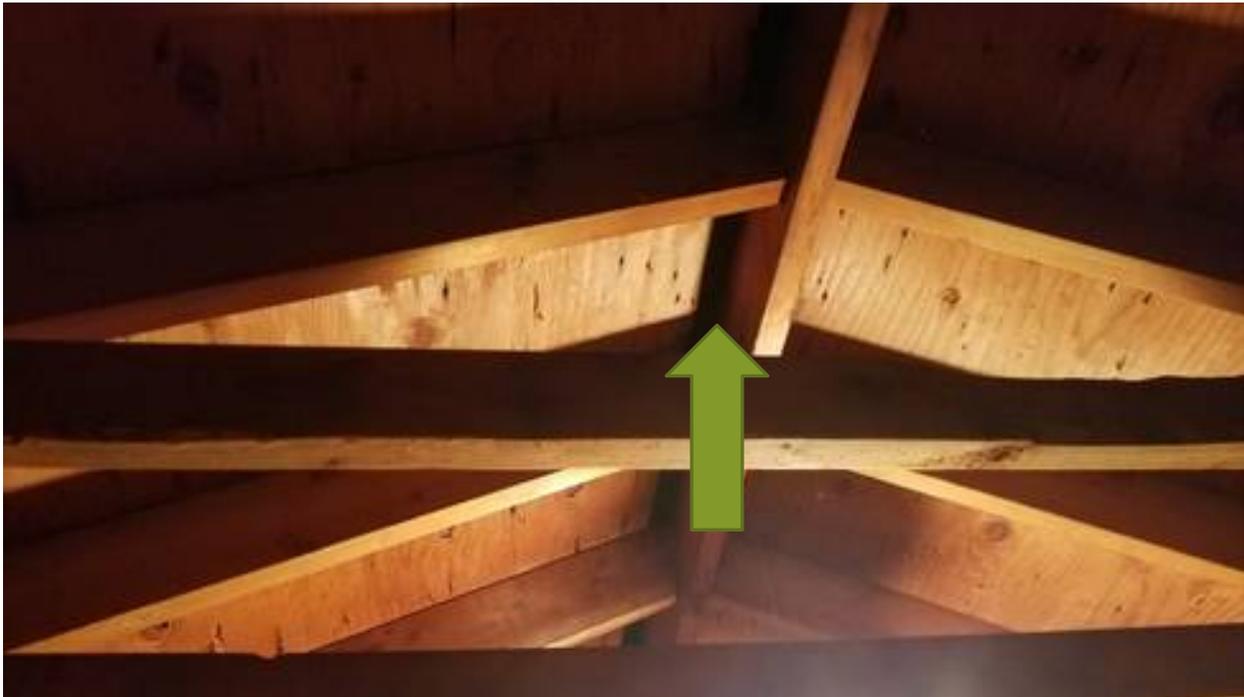
[3C.33](#) Vent, ridge: Missing. Repair is recommended and add soffit ventilation as well for proper function
